Site Accessibility Evaluation

James Park

Accessibility Evaluation

Evaluation Date: 12/16/2021

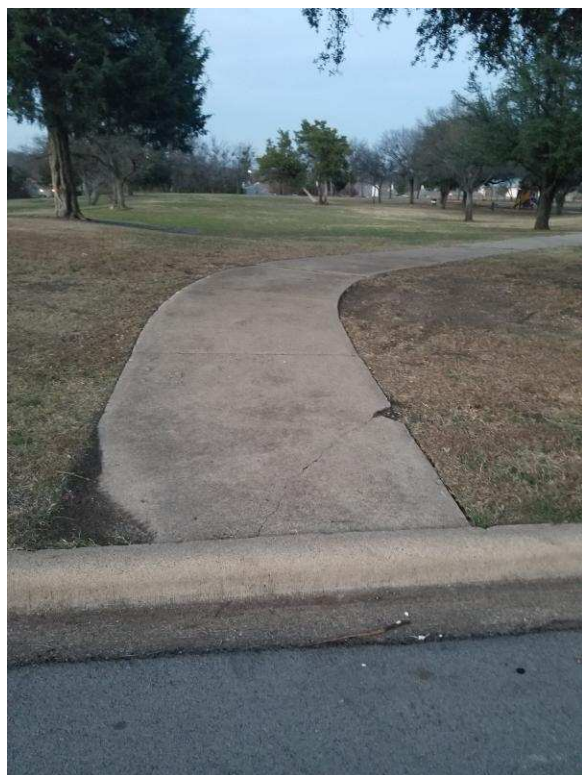
Barrier: 1

There is no accessible route of travel from the public way. At least one accessible route shall be provided within the site from accessible parking spaces and accessible passenger loading zones; public streets and sidewalks; and public transportation stops to the accessible building or facility they serve.

There is no accessible route
of travel from the public way
to the park.

Level 2 (High): Parking and exterior accessible routes (DOJ Level 1) – severely out of compliance; near a hospital, school, transit stop, govt. bldg., or other pedestrian attractor

Provide an accessible route of travel from the public way to the park path of travel.

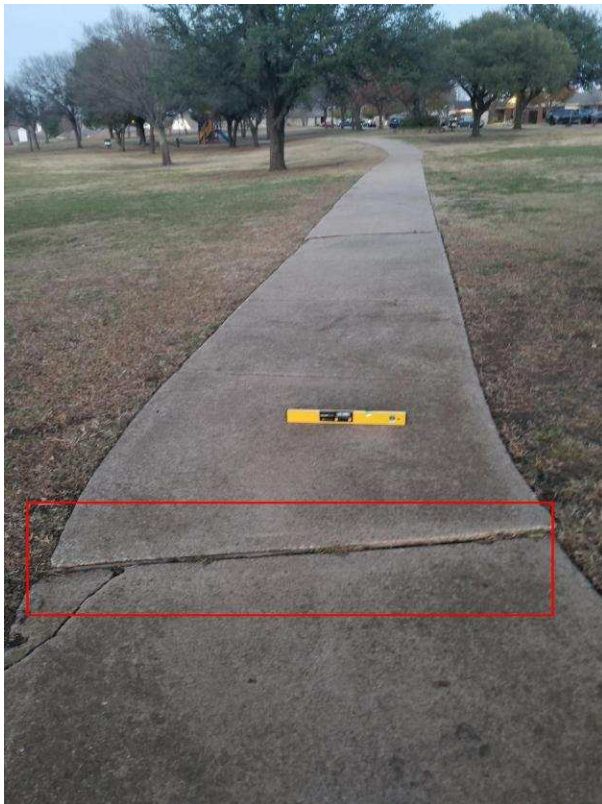
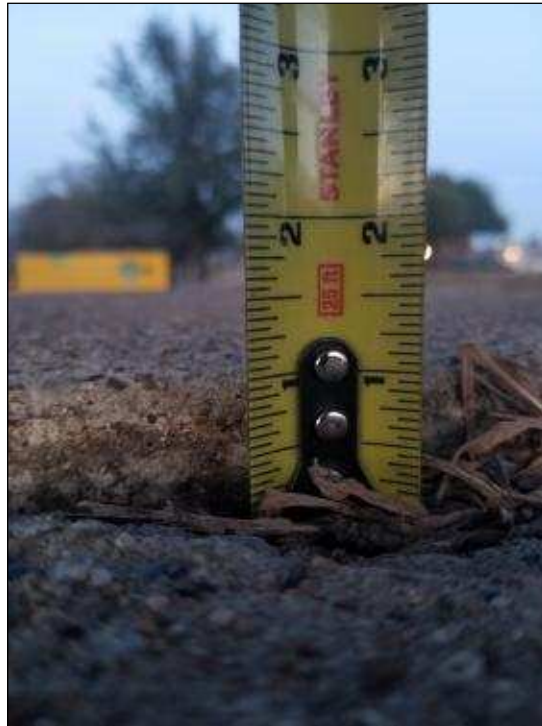
Barrier: 2

The walkway contains abrupt vertical edges and/or variations over 1/4 inch when 1/4 inch is the maximum vertical rise. Changes in level between 1/4 inch and 1/2 inch must be beveled at 1:2 or less. Changes in level greater than 1/2 inch must be by way of a ramp.

The path of travel contains
abrupt vertical edges
measuring 1 inch.

Level 4 (High): Parking and exterior accessible routes (DOJ Level 1) – moderately out of compliance

Modify the path of travel to provide a smooth level surface.

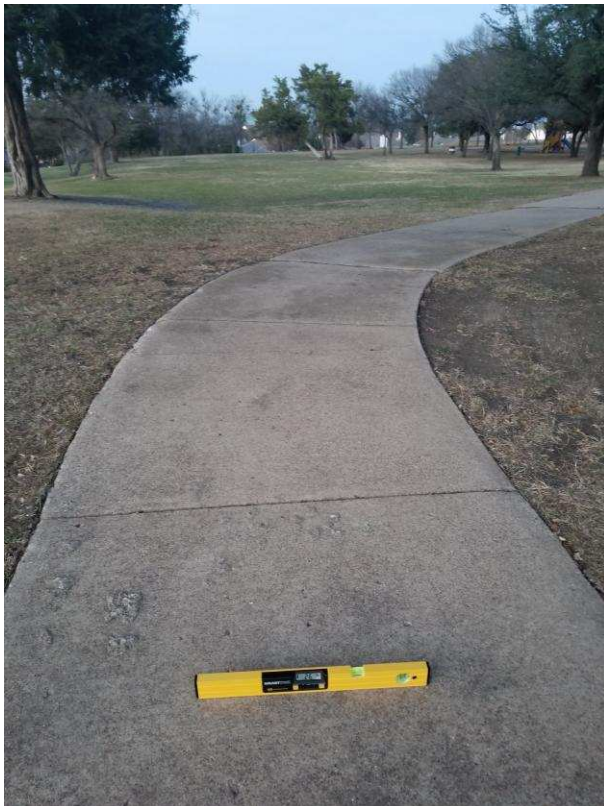
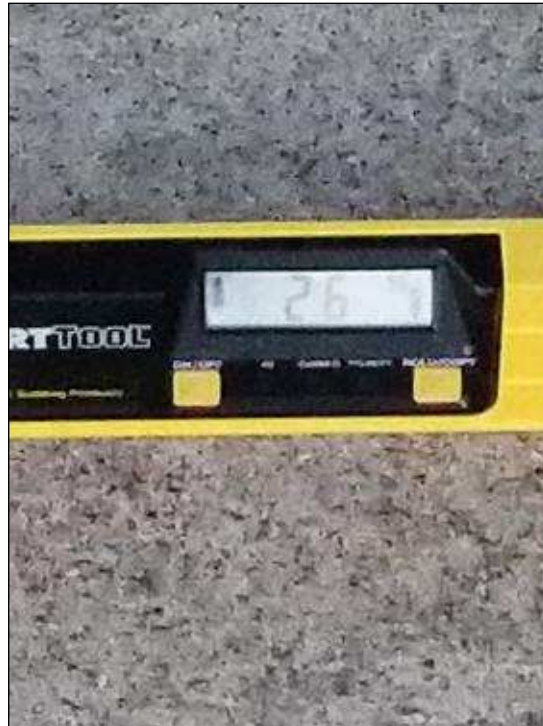
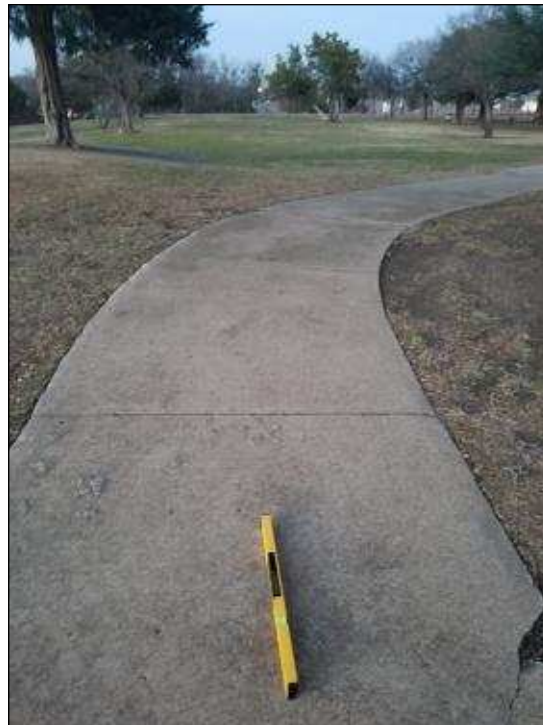
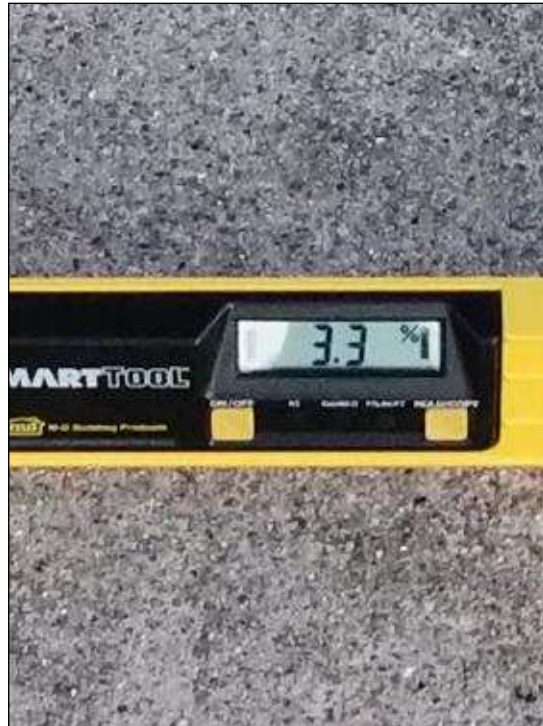
Barrier: 3

The accessible path of travel has cross slopes greater than 2 percent.

The accessible route of travel contains a cross slope of 2.6 percent.

Level 6 (Medium): Parking or exterior accessible routes (DOJ Level 1) – minimally out of compliance

Modify path of travel to achieve a cross slope that is no greater than 1:48 (2.08 percent).

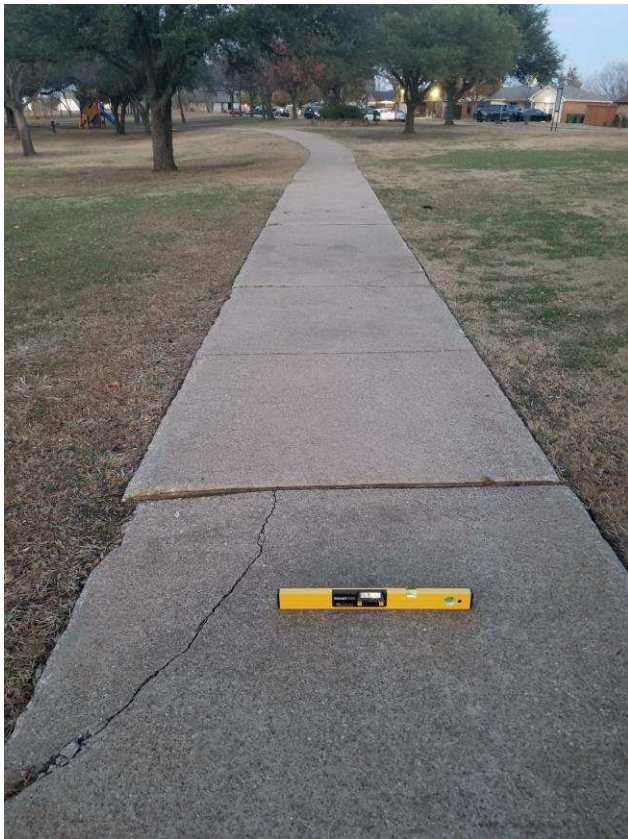
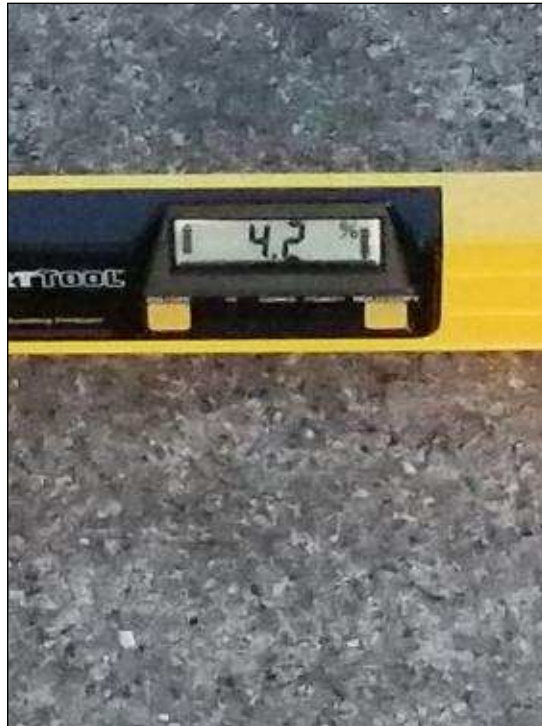
Barrier: 4

The accessible path of travel has cross slopes greater than 2 percent.

The accessible route of travel contains a cross slope of 4.2 percent.

Level 4 (High): Parking and exterior accessible routes (DOJ Level 1) – moderately out of compliance

Modify path of travel to achieve a cross slope that is no greater than 1:48 (2.08 percent).

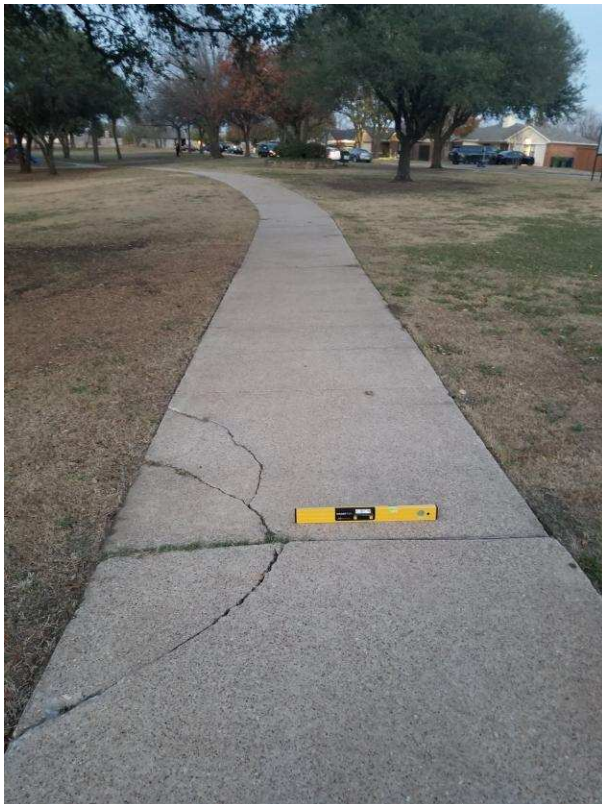
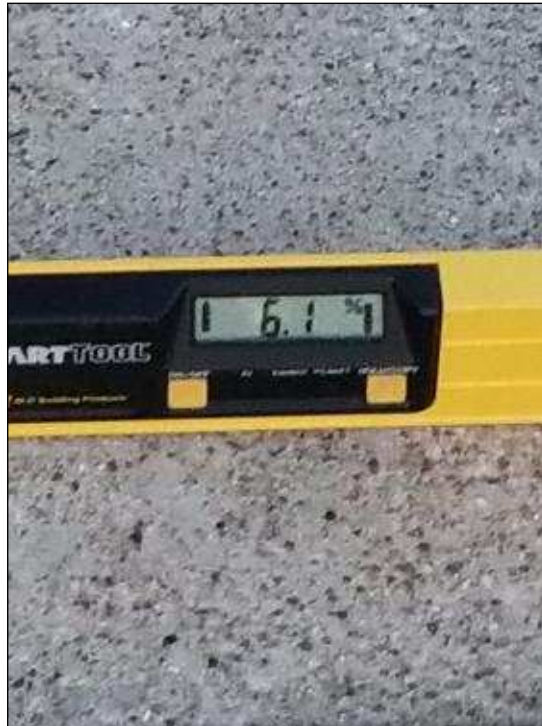
Barrier: 5

The accessible path of travel has cross slopes greater than 2 percent and changes in level.

The accessible route of travel contains a cross slope of 6.1 percent and changes in level.

Level 2 (High): Parking and exterior accessible routes (DOJ Level 1) – severely out of compliance; near a hospital, school, transit stop, govt. bldg., or other pedestrian attractor

Modify path of travel to achieve a cross slope that is no greater than 1:48 (2.08 percent) and eliminate changes in level.

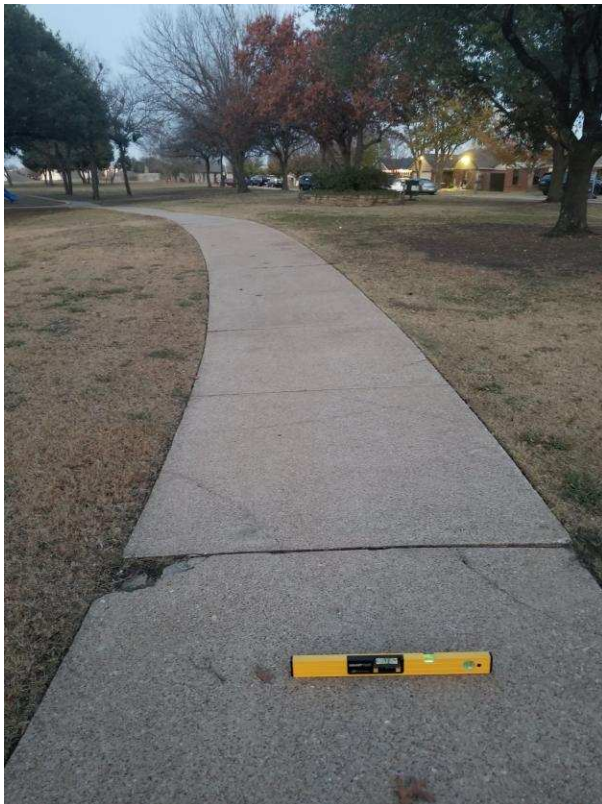
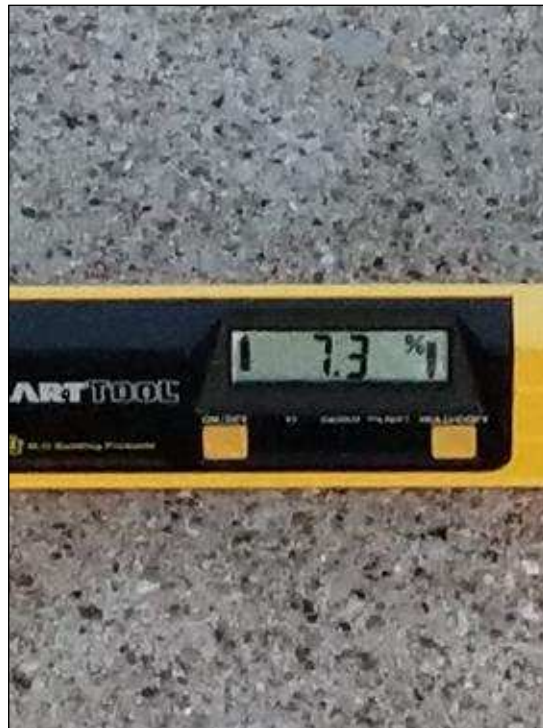
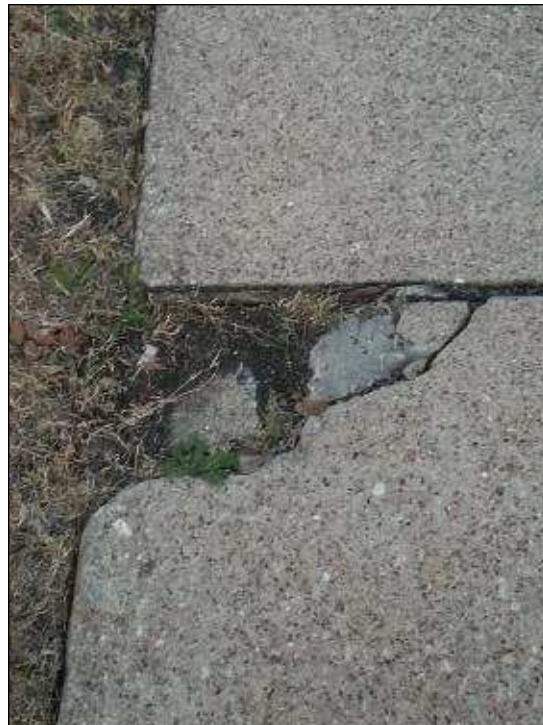
Barrier: 6

The accessible path of travel has cross slopes greater than 2 percent and changes in level.

The accessible route of travel contains a cross slope of 7.3 percent and changes in level.

Level 2 (High): Parking and exterior accessible routes (DOJ Level 1) – severely out of compliance; near a hospital, school, transit stop, govt. bldg., or other pedestrian attractor

Modify path of travel to achieve a cross slope that is no greater than 1:48 (2.08 percent) and eliminate changes in level.

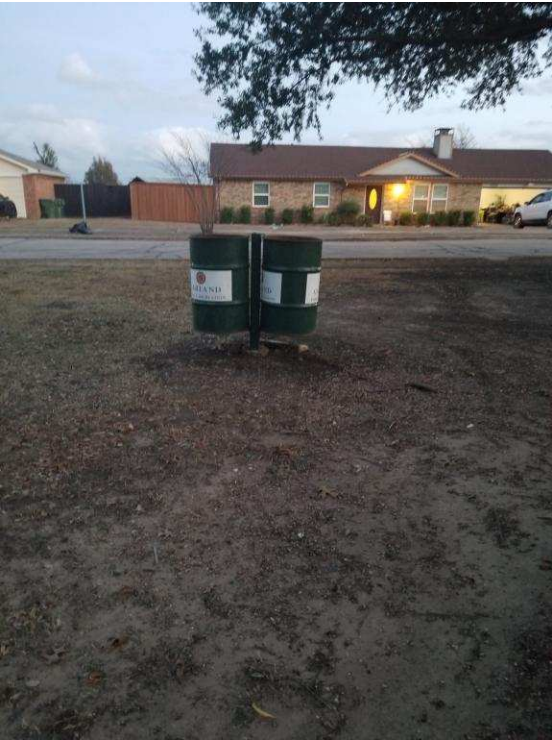
Barrier: 7

There is no accessible route to the trash cans. At least one accessible route shall connect accessible buildings, accessible facilities, accessible elements, and accessible spaces that are on the same site.

Citation:	Current Condition:	Budget Cost:
2010 ADAS Section: 206.2.2	There is no accessible route to the trash cans.	Base Cost: \$1,500.00
1991 ADAAG Section: 4.1.2(1)		Contingency Cost: \$300.00
		Design Cost: \$200.00
		Total Cost: \$2,000.00

Level 7 (Medium): Access to goods and services (DOJ Level 2) – minimally out of compliance
Restrooms (DOJ Level 3) – moderately out of compliance
Drinking fountains and public phones (DOJ Level 4 & 5) – severely out of compliance

Relocate the trash cans closer to the path of travel or provide an accessible route of travel to the trash cans.

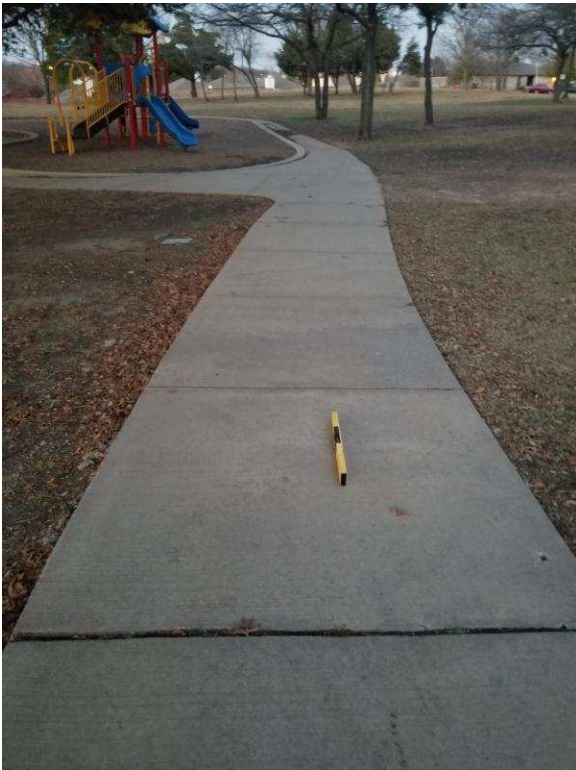
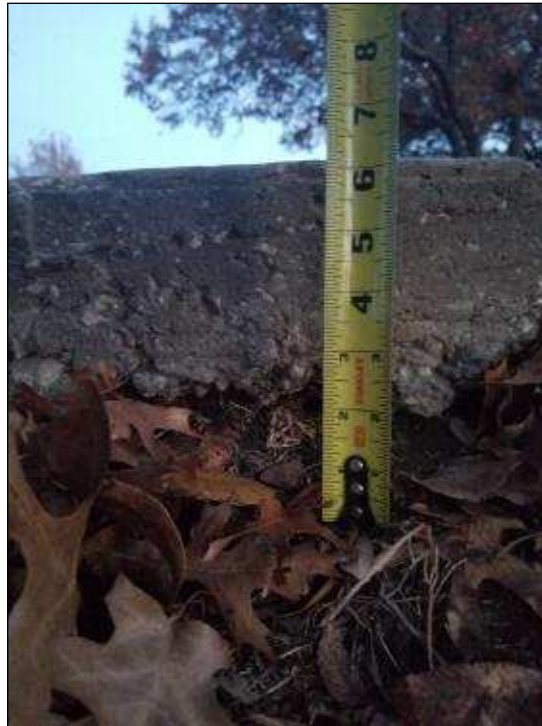
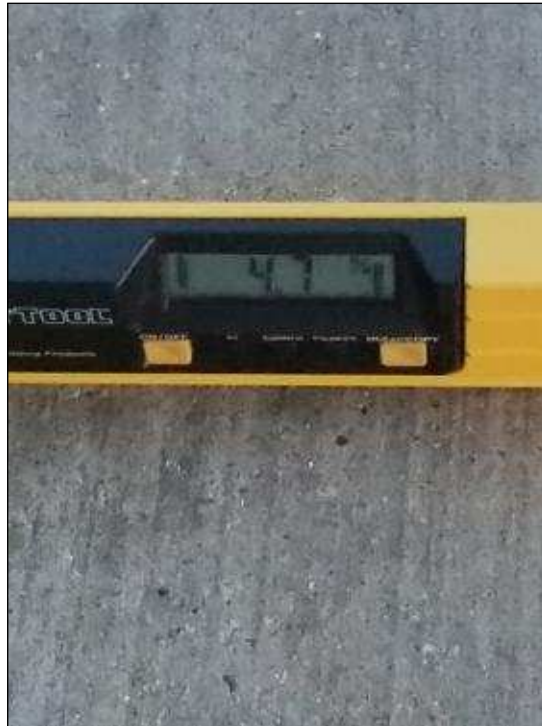
Barrier: 8

The required edge protection is missing. The floor or ground surface shall extend 12 inches minimum beyond the inside face of a handrail or a curb or barrier shall be provided that prevents the passage of a 4 inch diameter sphere, where any portion of the sphere is within 4 inches of the finish floor or ground surface.

The path of travel has a drop-off greater than 6 inches and edge protection has not been provided.

Level 4 (High): Parking and exterior accessible routes (DOJ Level 1) – moderately out of compliance

Provide edge protection at the areas containing drop-offs along the path of travel.

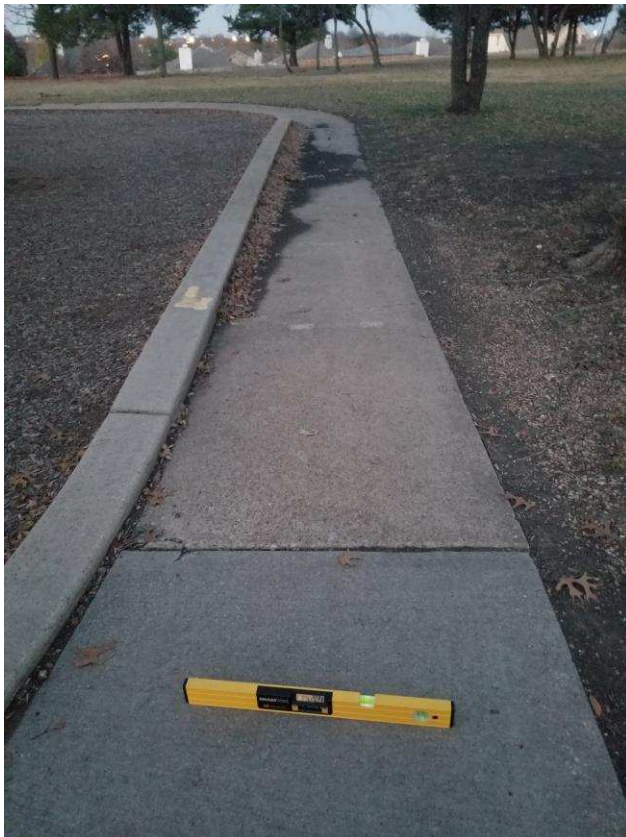
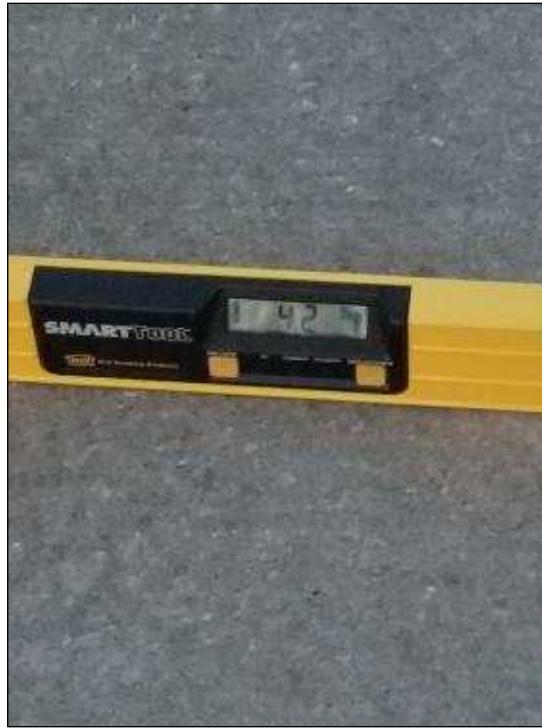
Barrier: 9

The accessible path of travel has cross slopes greater than 2 percent.

The accessible route of travel contains a cross slope of 4.2 percent.

Level 4 (High): Parking and exterior accessible routes (DOJ Level 1) – moderately out of compliance

Modify path of travel to achieve a cross slope that is no greater than 1:48 (2.08 percent).

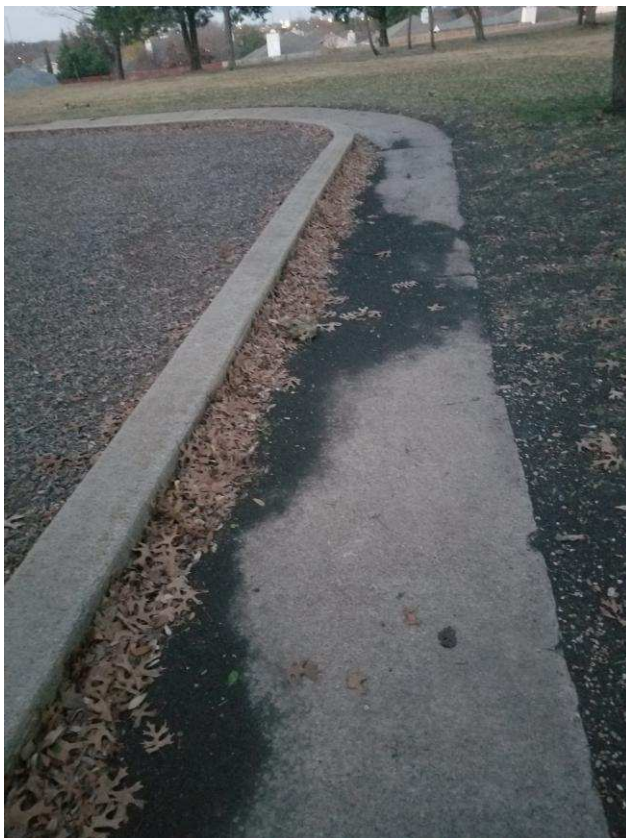
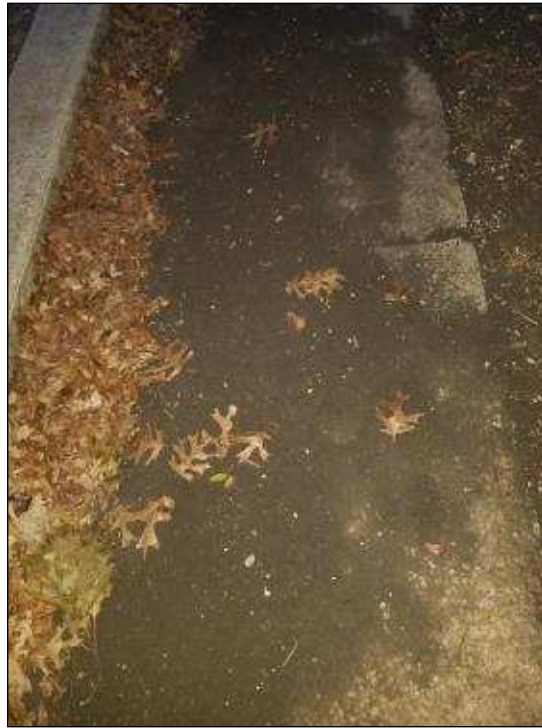
Barrier: 10

The accessible route contains surface materials that do not provide for a stable, firm, slip-resistant surface.

The accessible route of travel contains leaves and dirt build-up that is not stable, firm, or slip-resistant.

Level 4 (High): Parking and exterior accessible routes (DOJ Level 1) – moderately out of compliance

Modify the accessible route of travel to eliminate the collection of leaves and dirt build-up.

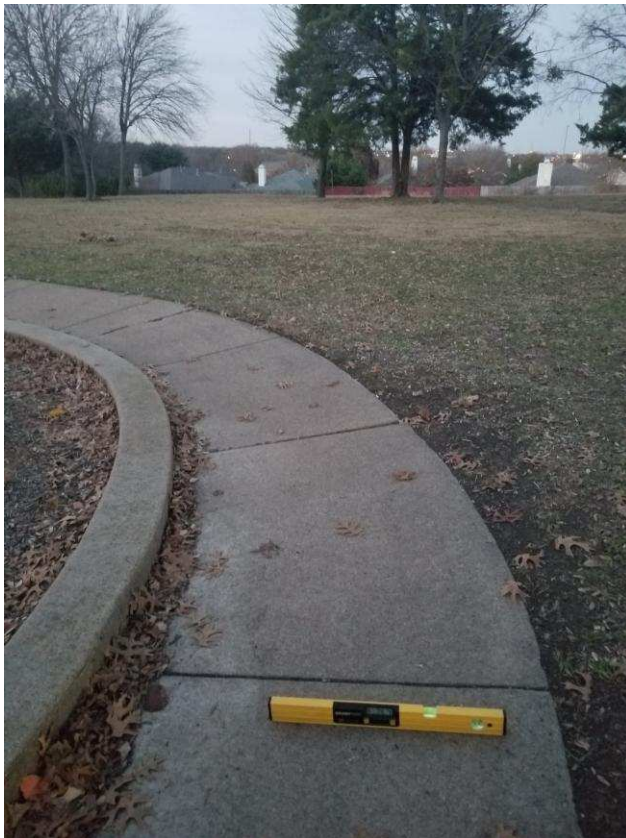
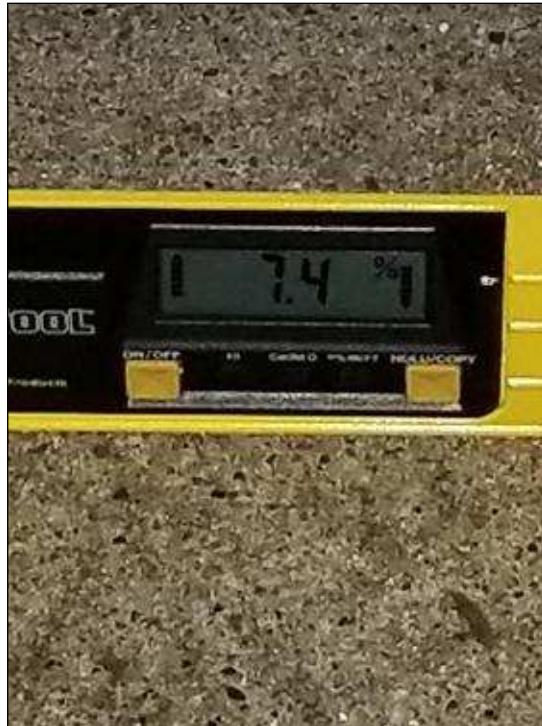
Barrier: 11

The accessible path of travel has cross slopes greater than 2 percent.

The accessible route of travel contains a cross slope of 7.4 percent.

Level 2 (High): Parking and exterior accessible routes (DOJ Level 1) – severely out of compliance; near a hospital, school, transit stop, govt. bldg., or other pedestrian attractor

Modify path of travel to achieve a cross slope that is no greater than 1:48 (2.08 percent).

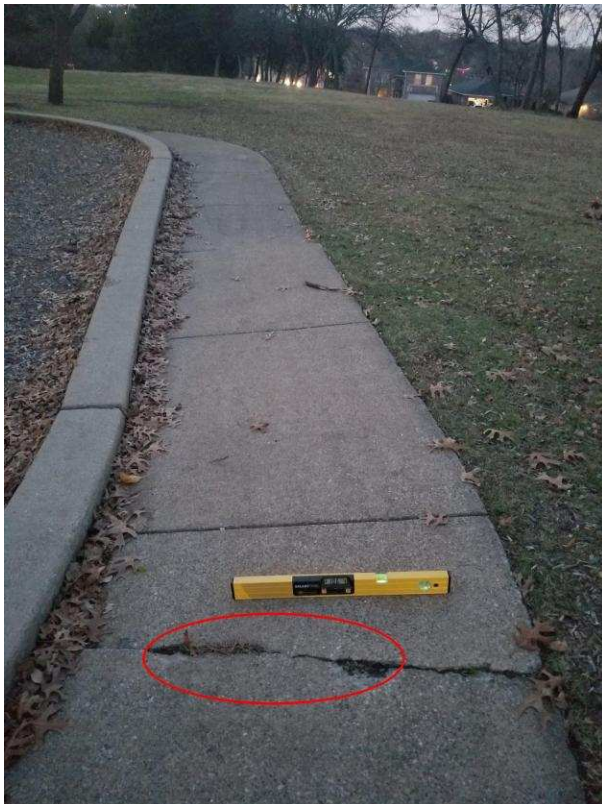
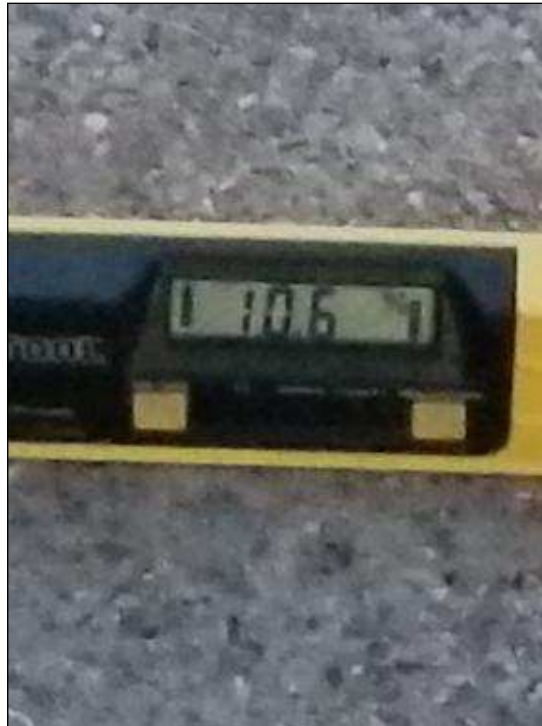
Barrier: 12

The accessible path of travel has cross slopes greater than 2 percent and changes in level.

The accessible route of travel contains a cross slope of 10.6 percent and changes in level.

Level 2 (High): Parking and exterior accessible routes (DOJ Level 1) – severely out of compliance; near a hospital, school, transit stop, govt. bldg., or other pedestrian attractor

Modify path of travel to achieve a cross slope that is no greater than 1:48 (2.08 percent) and eliminate changes in level.

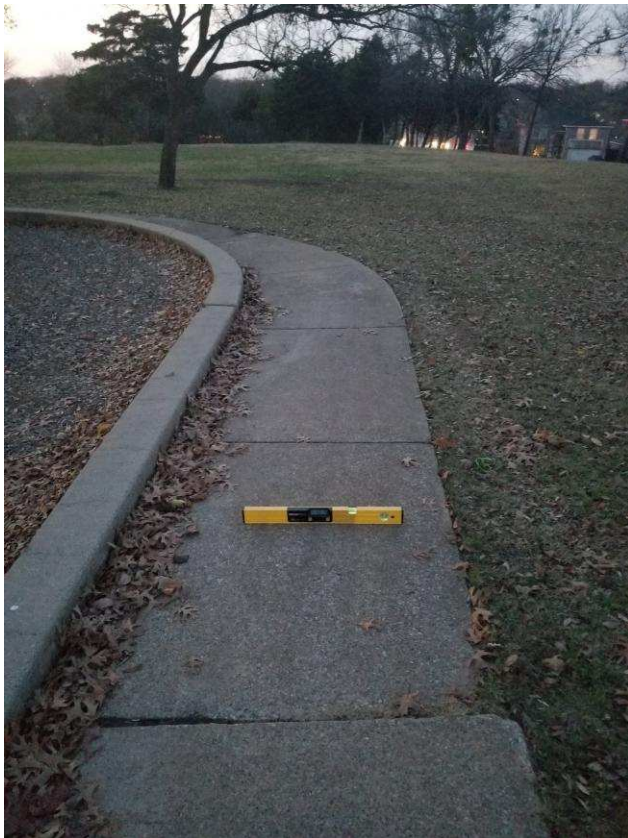
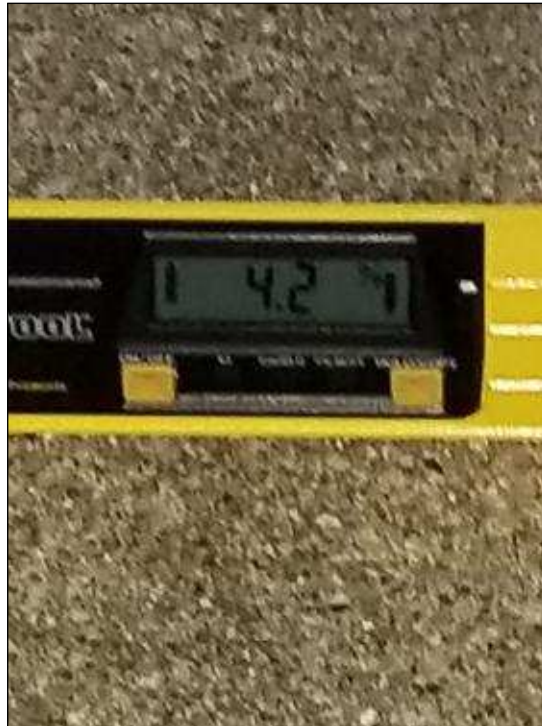
Barrier: 13

The accessible path of travel has cross slopes greater than 2 percent and changes in level.

The accessible route of travel contains a cross slope of 4.2 percent and changes in level.

Level 4 (High): Parking and exterior accessible routes (DOJ Level 1) – moderately out of compliance

Modify path of travel to achieve a cross slope that is no greater than 1:48 (2.08 percent) and eliminate changes in level.

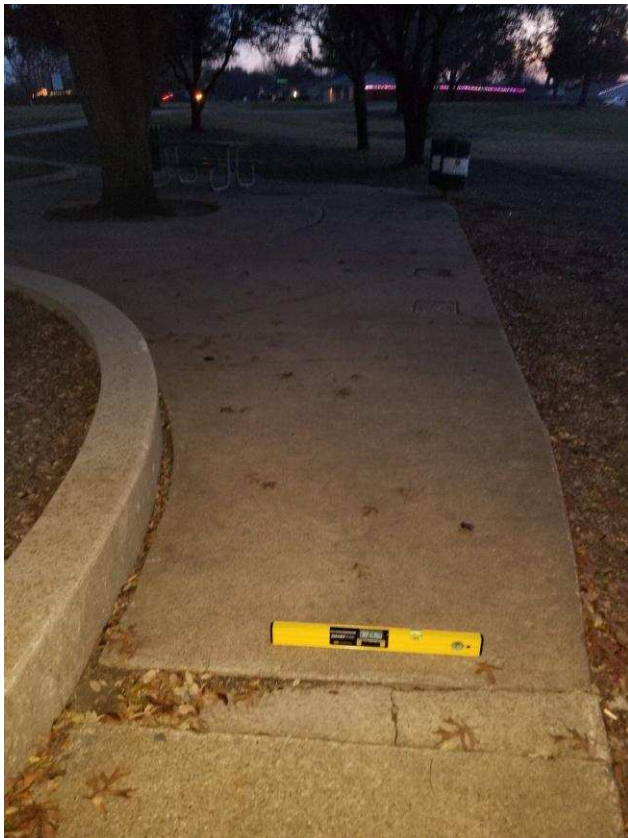
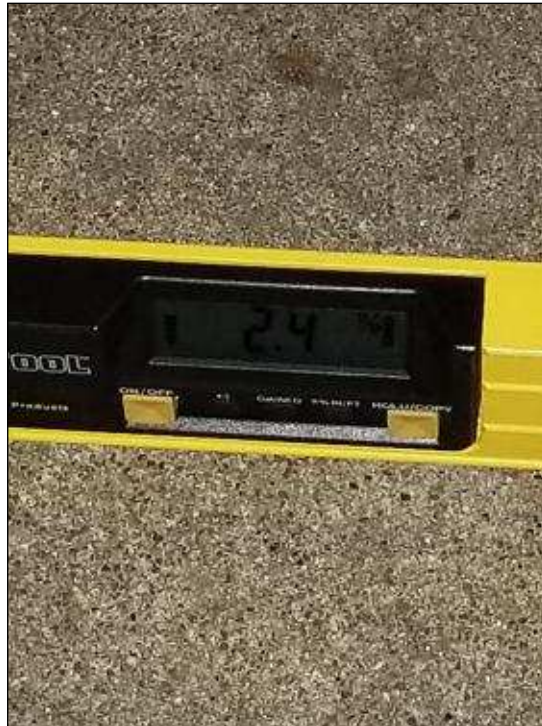
Barrier: 14

The accessible path of travel has cross slopes greater than 2 percent and changes in level.

The accessible route of travel contains a cross slope of 2.4 percent and changes in level.

Level 4 (High): Parking and exterior accessible routes (DOJ Level 1) – moderately out of compliance

Modify path of travel to achieve a cross slope that is no greater than 1:48 (2.08 percent) and eliminate changes in level.

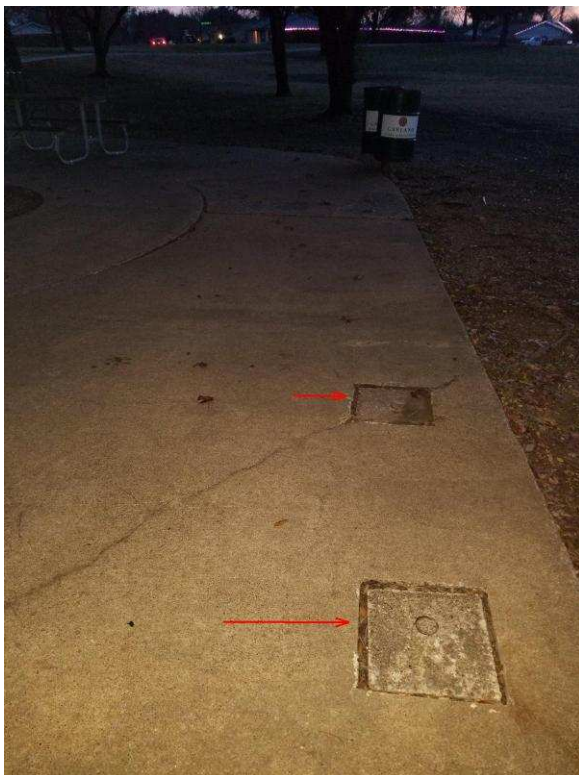
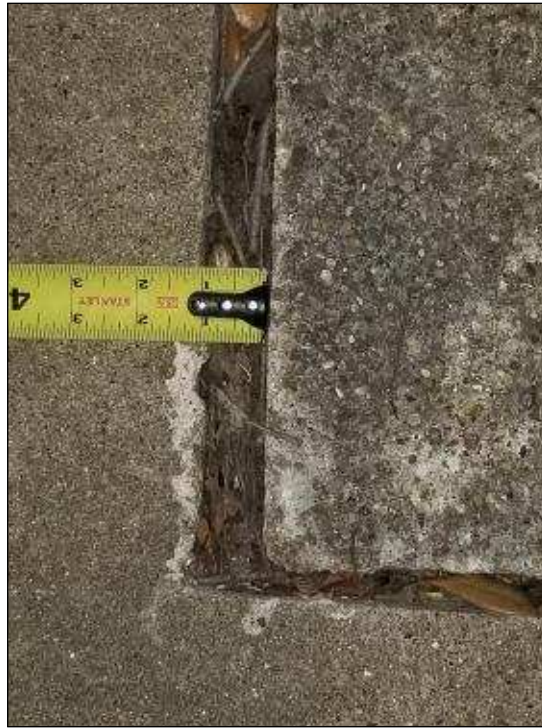
Barrier: 15

The concrete expansion joints are spaced greater than 1/2 inch. Openings in ground surfaces shall not allow passage of a sphere more than 1/2 inch diameter.

The concrete expansion joints are spaced greater than 1/2 inch.

Level 6 (Medium): Parking or exterior accessible routes (DOJ Level 1) – minimally out of compliance

Fill the expansion joints to alleviate gap.

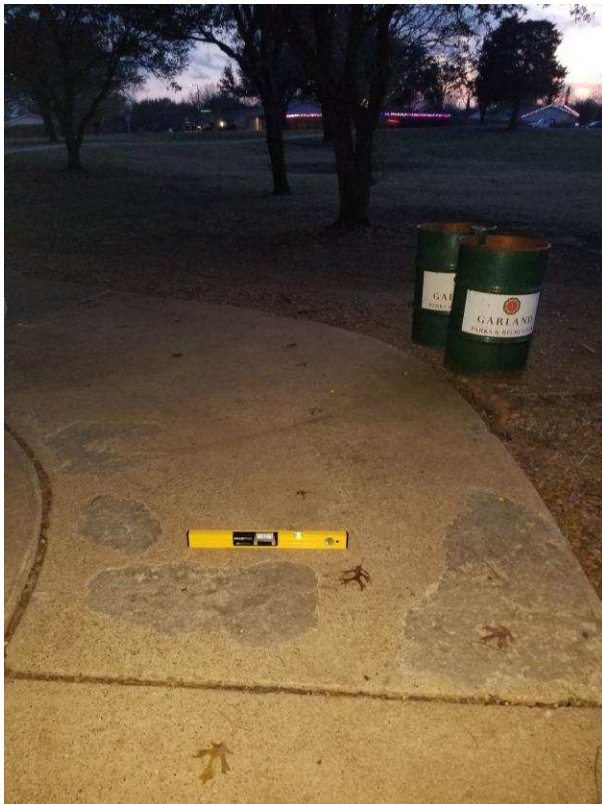
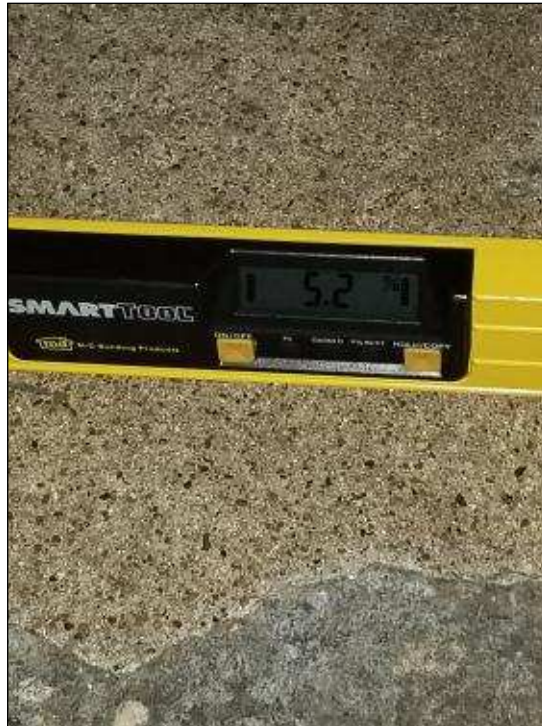
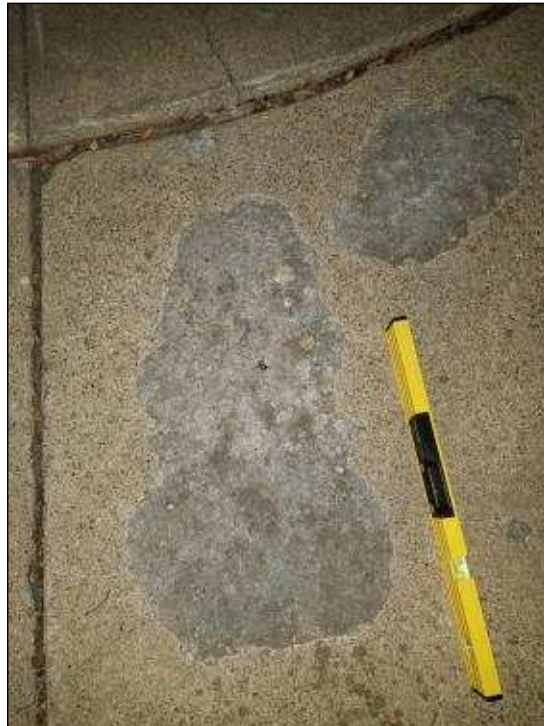
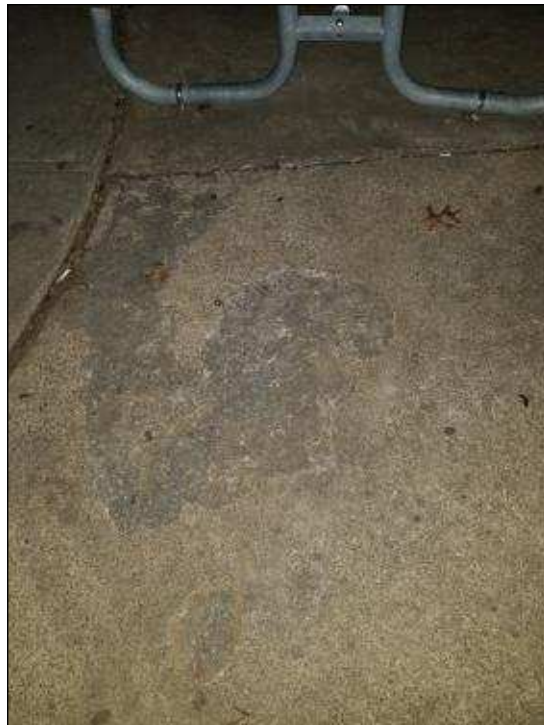
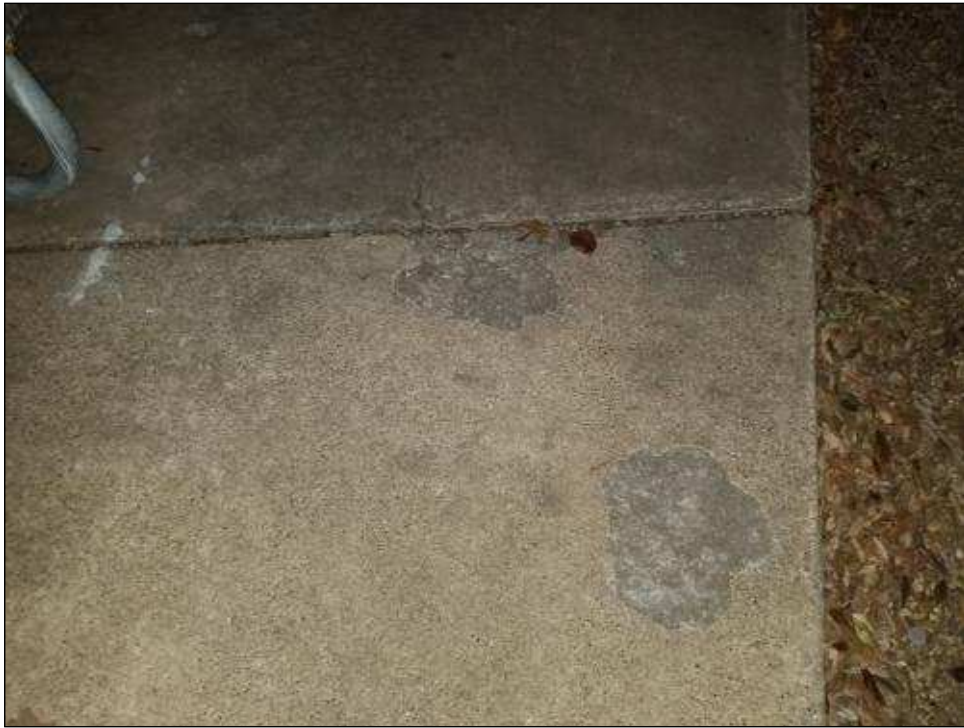
Barrier: 16

The accessible path of travel has cross slopes greater than 2 percent and abrupt changes in level.

The accessible route of travel contains a cross slope of 5.2 percent and abrupt changes in level.

Level 2 (High): Parking and exterior accessible routes (DOJ Level 1) – severely out of compliance; near a hospital, school, transit stop, govt. bldg., or other pedestrian attractor

Modify path of travel to achieve a cross slope that is no greater than 1:48 (2.08 percent) and eliminate changes in level.

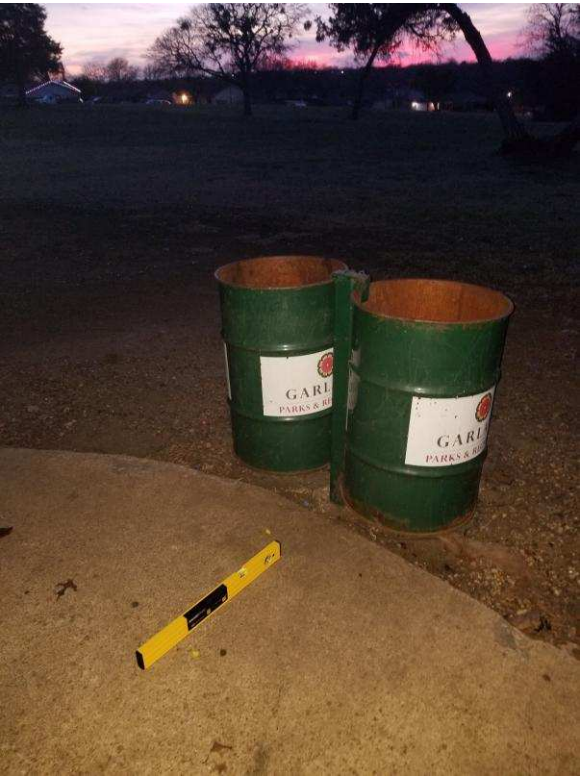
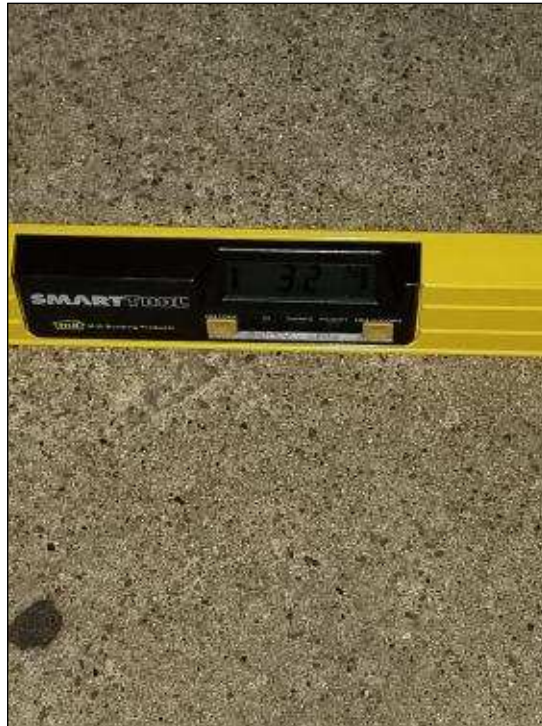
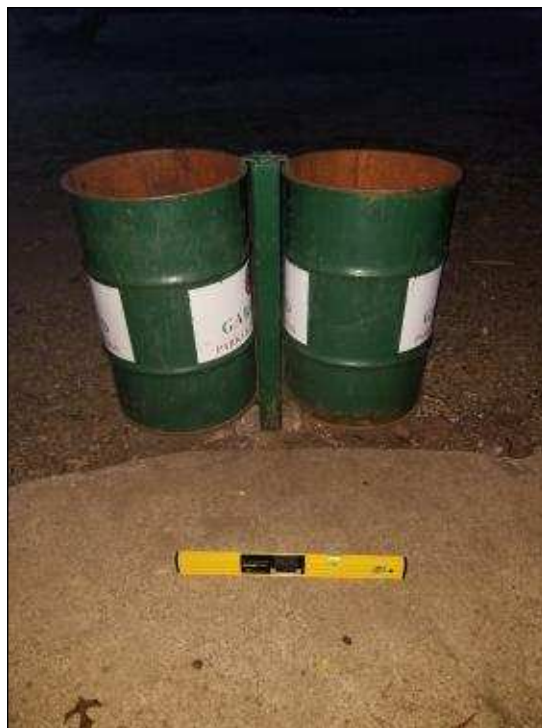
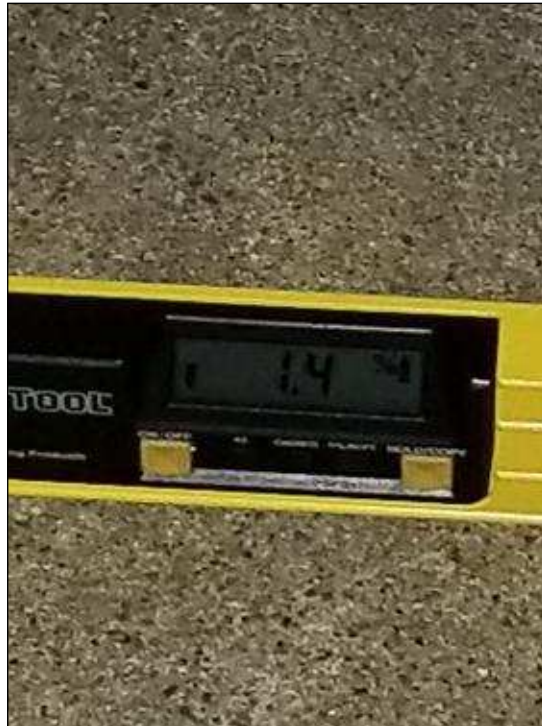
Barrier: 17

The clear floor space required at the trash cans is not flat (2 percent or 1:48 maximum slope) in all directions. Changes in level are not permitted at required clear floor or ground space except that slopes not steeper than 1:48 shall be permitted.

Citation:	Current Condition:	Budget Cost:
2010 ADAS Section: 305.2	The clear floor space required at the trash cans	Base Cost: \$1,500.00
1991 ADAAG Section: 4.2.4.1	contains a 3.2 percent slope.	Contingency Cost: \$300.00
		Design Cost: \$200.00
		Total Cost: \$2,000.00

Level 5 (Medium): Access to goods and services issues (DOJ Level 2) – severely out of compliance

Modify the clear floor space at the trash cans to provide a slope no greater than 2 percent in any direction.

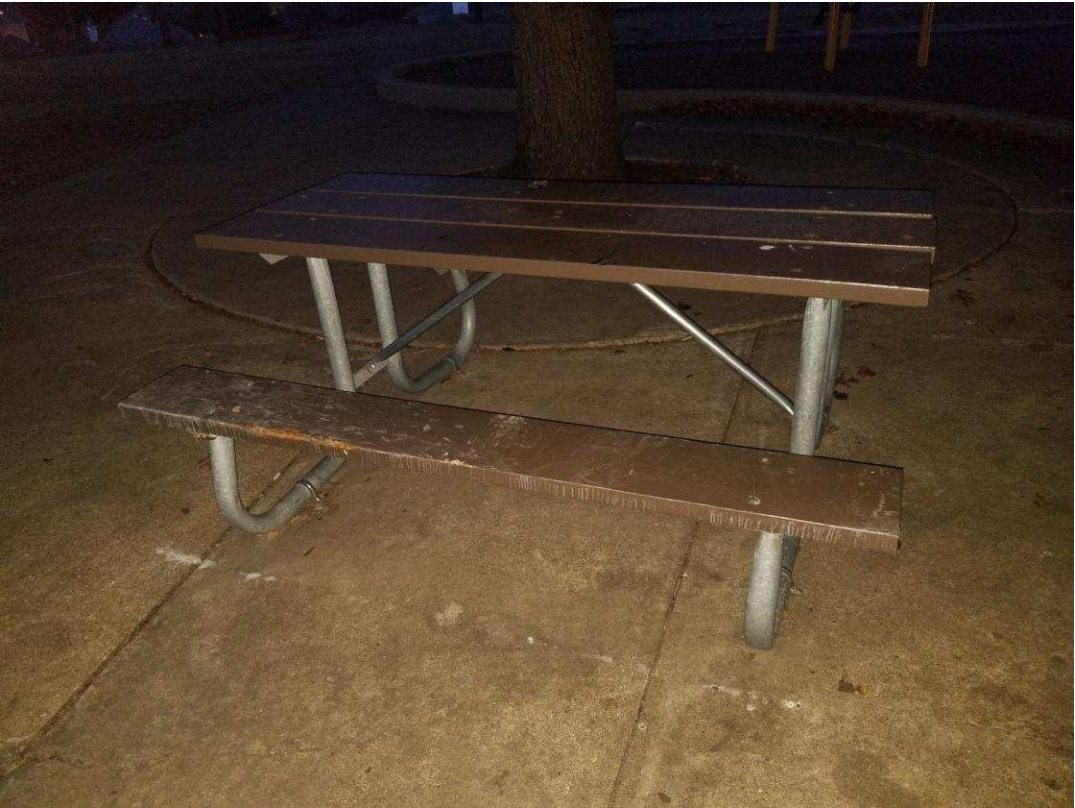
Barrier: 18

There are no accessible tables in the park. At least 5 percent of each type in each functional area of dining surfaces must be accessible and must be dispersed throughout the space or facility containing dining surfaces.

Citation:	Current Condition:	Budget Cost:
2010 ADAS Section: 226.1	There is one table provided and it is not accessible.	Base Cost: \$800.00
1991 ADAAG Section: 5.1		Contingency Cost: \$200.00
		Design Cost: \$100.00
		Total Cost: \$1,100.00

Barrier Priority:
Level 5 (Medium): Access to goods and services issues (DOJ Level 2) – severely out of compliance

Possible Solutions:
Provide an accessible table in the park.

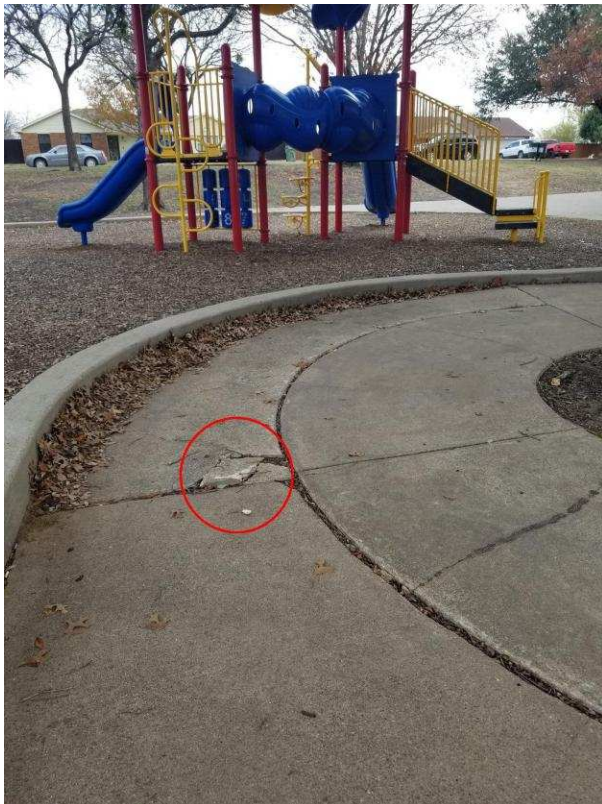
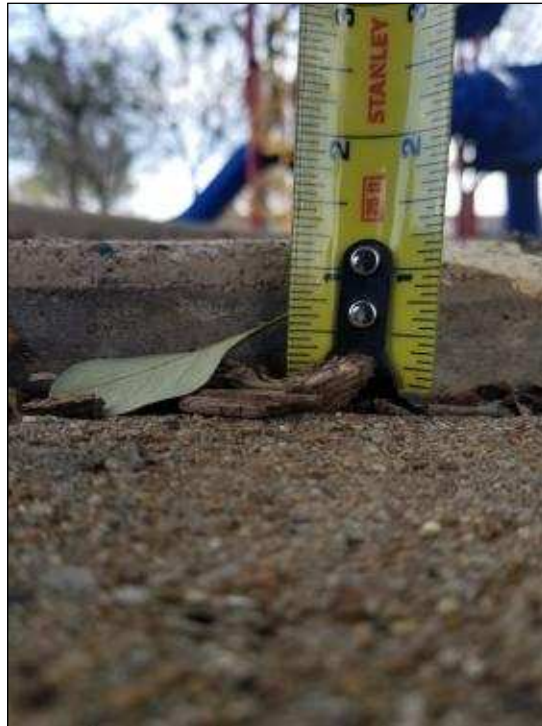
Barrier: 19

The walkway contains abrupt vertical edges and/or variations over 1/4 inch where 1/4 inch is the maximum vertical rise. Changes in level between 1/4 inch and 1/2 inch must be beveled at 1:2 or less.

The walkway contains
abrupt vertical edges and/or
variations over 1/4 inch.

Level 2 (High): Parking and exterior accessible routes (DOJ Level 1) – severely out of compliance; near a hospital, school, transit stop, govt. bldg., or other pedestrian attractor

Modify the path of travel to provide a smooth level surface.
