Site Accessibility Evaluation

James Park

Accessibility Evaluation

Evaluation Date: 12/16/2021

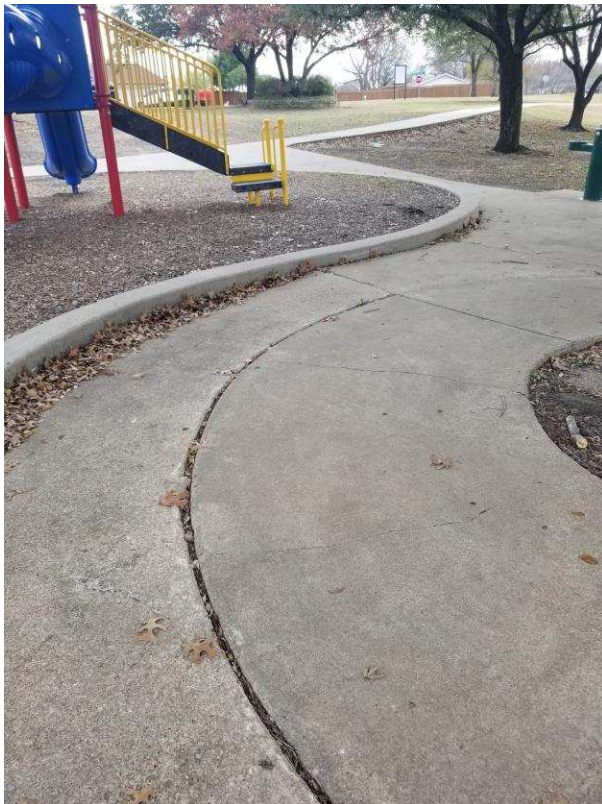
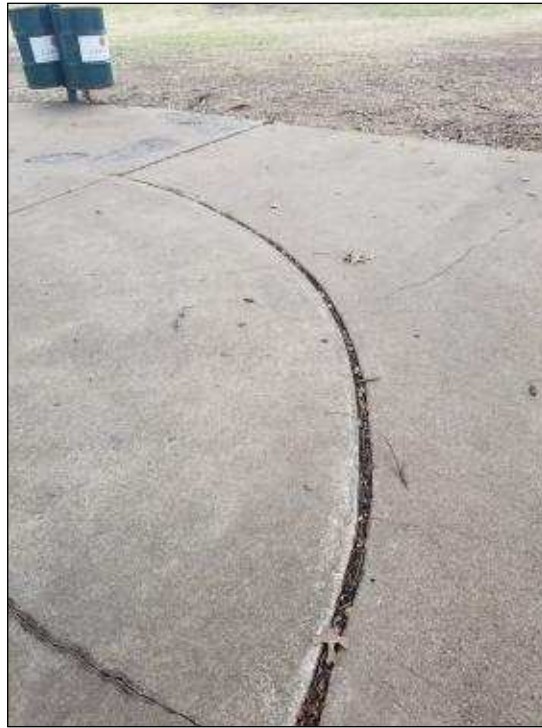
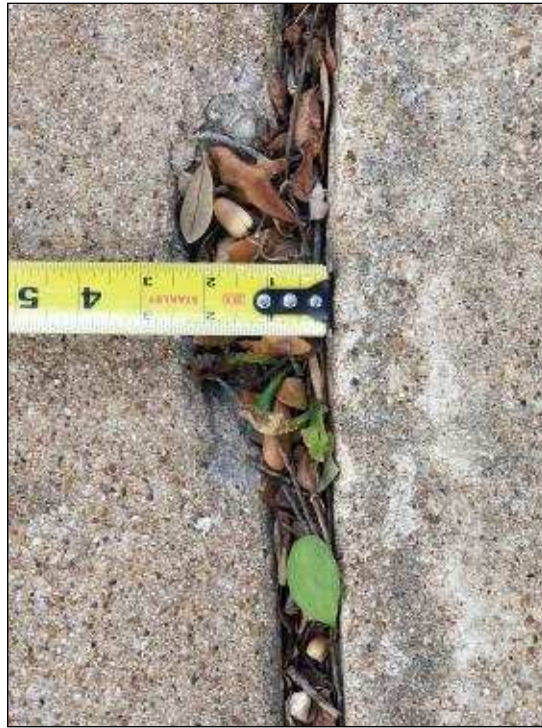
Barrier: 20

The concrete expansion joint is spaced greater than 1/2 inch. Openings in floor or ground surfaces shall not allow passage of a sphere more than 1/2 inch diameter. Elongated openings shall be placed so that the long dimension is perpendicular to the dominant direction of travel.

The entire area around the tree contains a concrete expansion joint spaced greater than 1/2 inch.

Level 4 (High): Parking and exterior accessible routes (DOJ Level 1) – moderately out of compliance

Fill the expansion joint in the entire area around the tree to alleviate gaps.

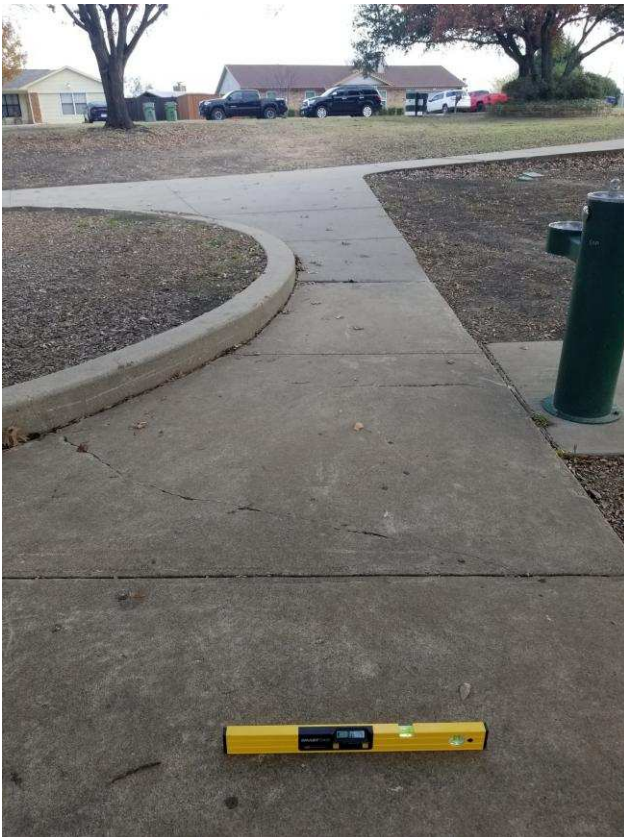
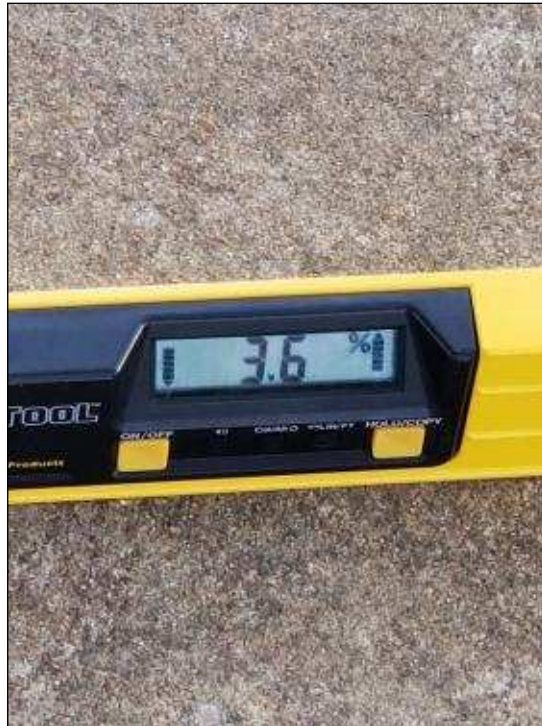
Barrier: 21

The accessible path of travel has cross slopes greater than 2 percent.

The accessible route of travel contains a cross slope of 3.6 percent.

Level 4 (High): Parking and exterior accessible routes (DOJ Level 1) – moderately out of compliance

Modify path of travel to achieve a cross slope that is no greater than 1:48 (2.08 percent).

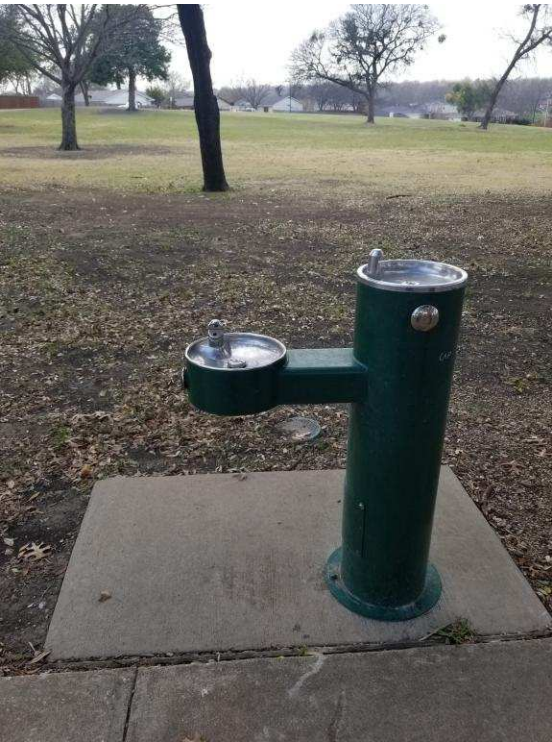
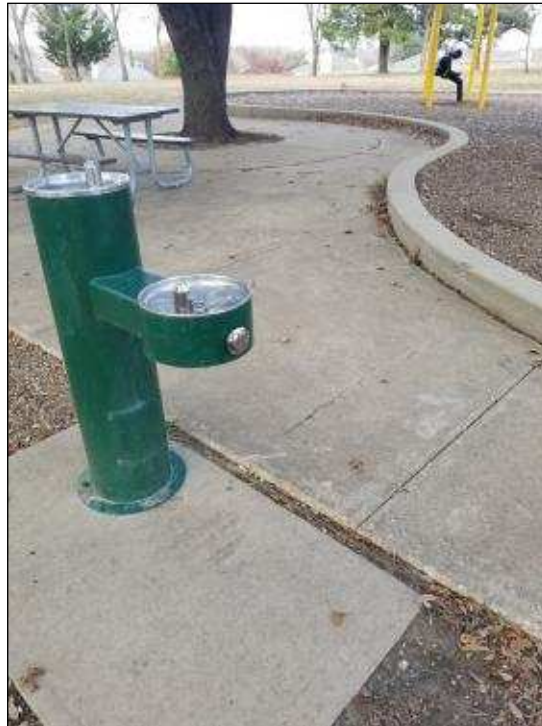
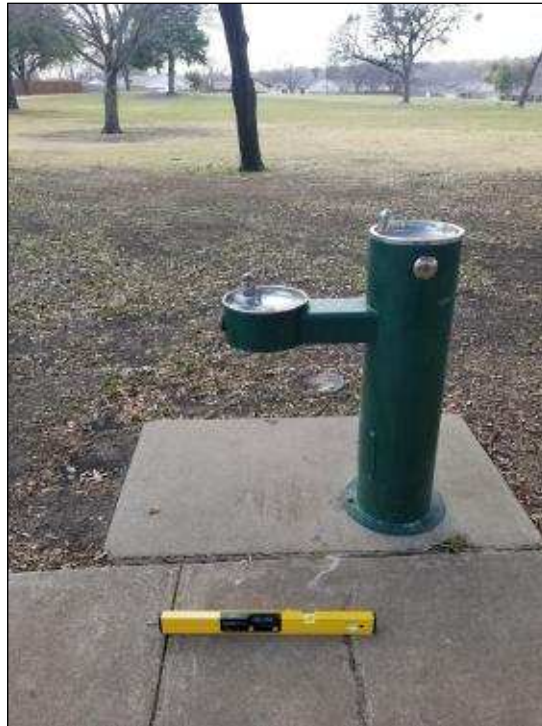
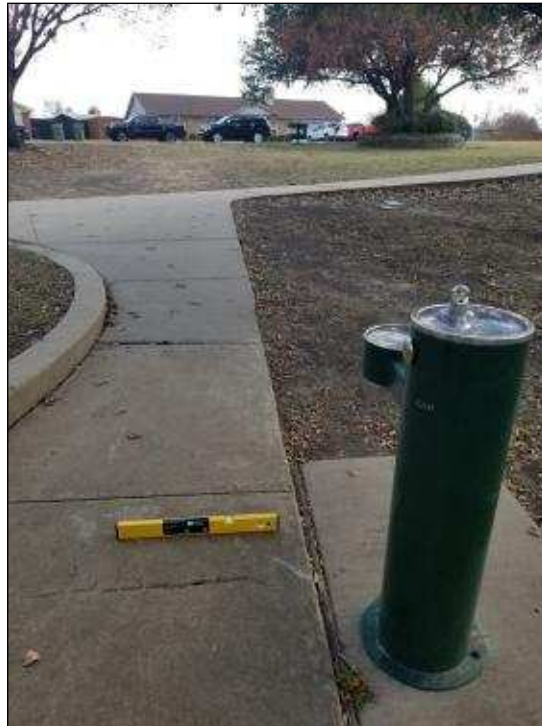
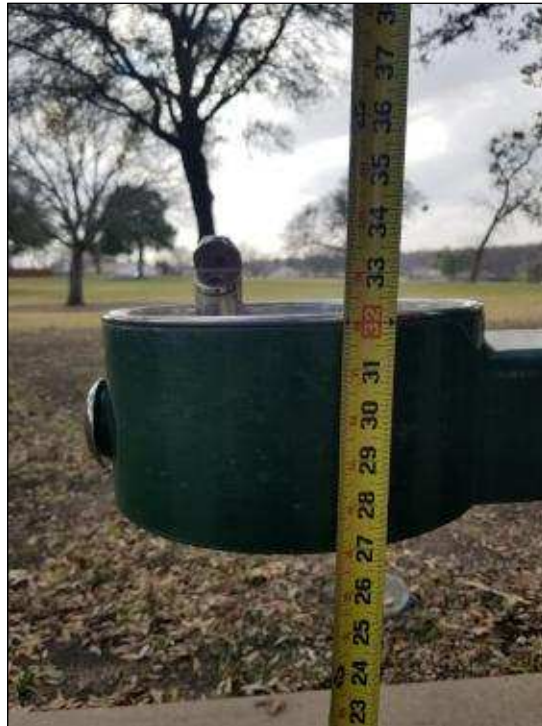
Barrier: 22

The drinking fountain has multiple violations.
Drinking fountains must be on an accessible route that provides a 30 inch by 48 inch clear floor space centered on the low unit, allowing a forward approach. The spout shall provide a flow of water 4 inches high minimum and shall be located 5 inches maximum from the front of the unit.

Citation:	Current Condition:	Budget Cost:
2010 ADAS Section: 403.5.1, 602.1	The drinking fountain has multiple violations and was not operational at time of evaluation.	Base Cost: \$2,500.00 Contingency Cost: \$500.00 Design Cost: \$400.00 Total Cost: \$3,400.00
1991 ADAAG Section: 4.15.1

Barrier Priority:
Level 5 (Medium): Access to goods and services issues (DOJ Level 2) – severely out of compliance

Possible Solutions:
Modify the area at the water fountain to provide the required clear floor space with slopes no greater than 2 percent in any direction, and adjust the water flow to provide a minimum of 4 inches.

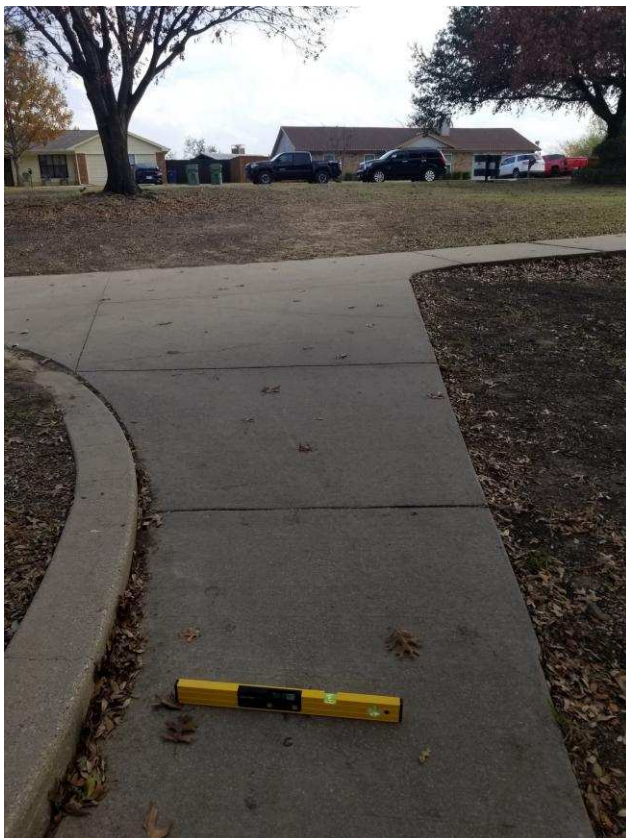
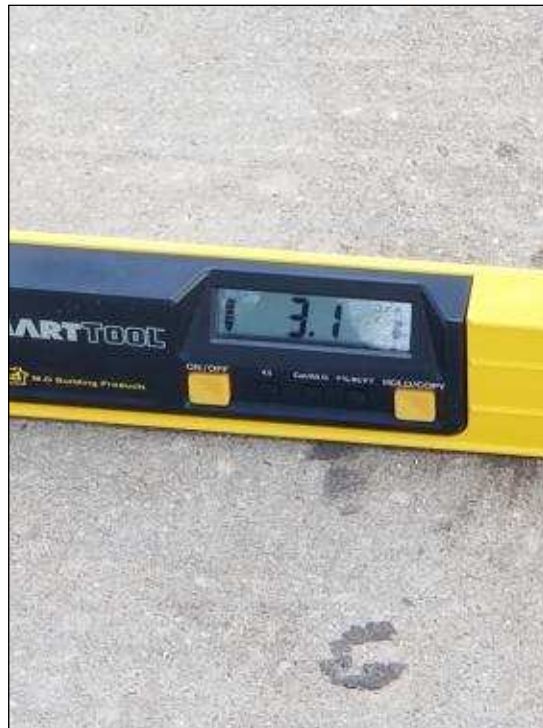
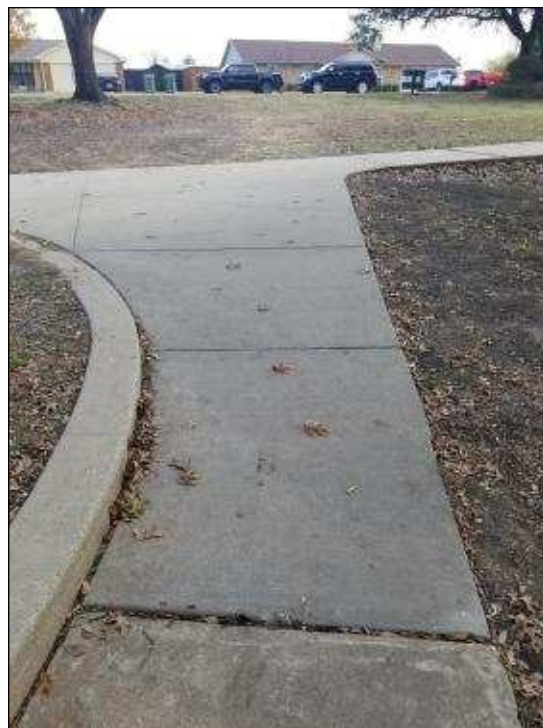
Barrier: 23

The accessible path of travel has cross slopes greater than 2 percent and abrupt changes in level.

The accessible route of travel contains a cross slope of 3.1 percent and abrupt changes in level.

Level 4 (High): Parking and exterior accessible routes (DOJ Level 1) – moderately out of compliance

Modify path of travel to achieve a cross slope that is no greater than 1:48 (2.08 percent) and to eliminate changes in level.

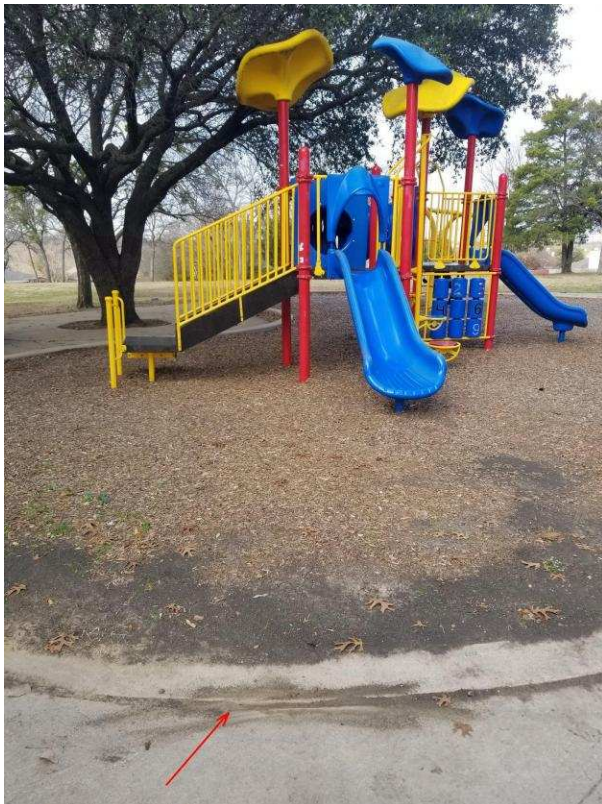
Barrier: 24

The ramp to the playground contains abrupt vertical edges and/or variations over 1/4 inch.

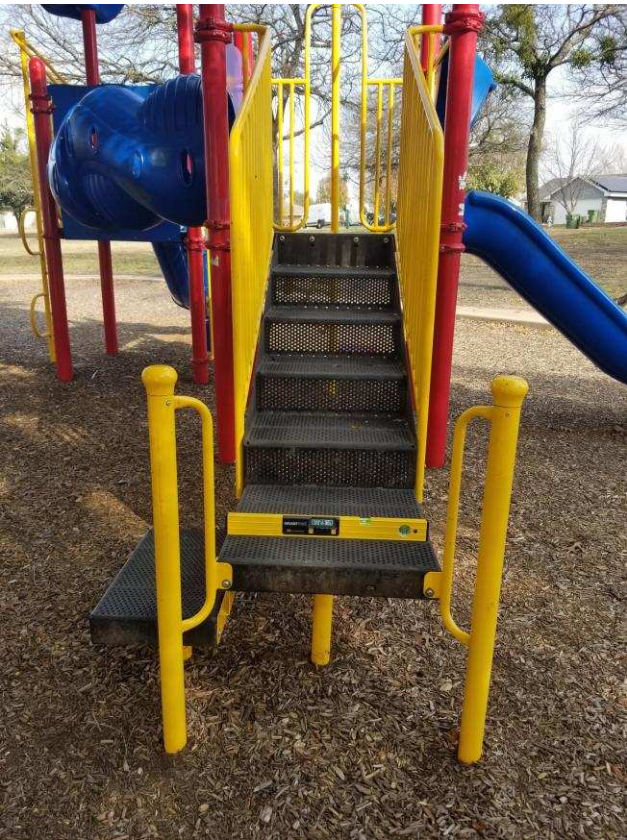
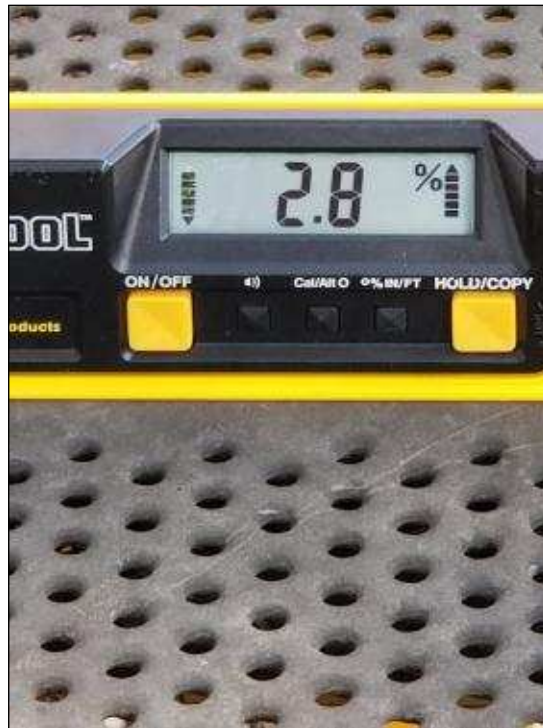
Citation:	Current Condition:	Budget Cost:
2010 ADAS Section: 1008.3.1.1	The transfer platform contains a 2.8 percent slope.	Base Cost: \$1,500.00 Contingency Cost: \$300.00 Design Cost: \$200.00 Total Cost: \$2,000.00

Barrier Priority:
Level 5 (Medium): Access to goods and services issues (DOJ Level 2) – severely out of compliance

Possible Solutions:
Modify the transfer platform to provide a level surface.

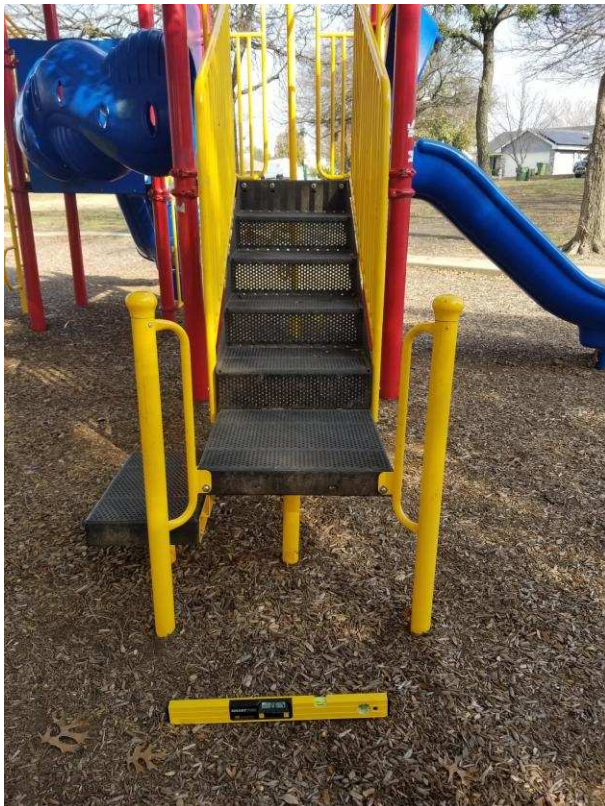
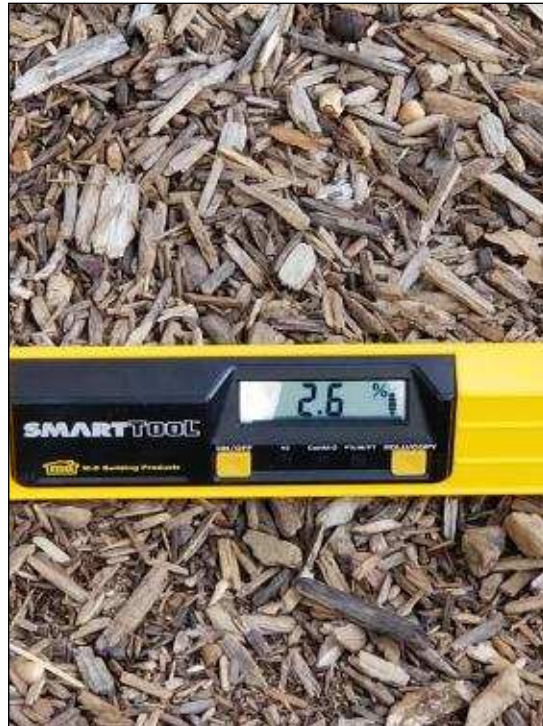
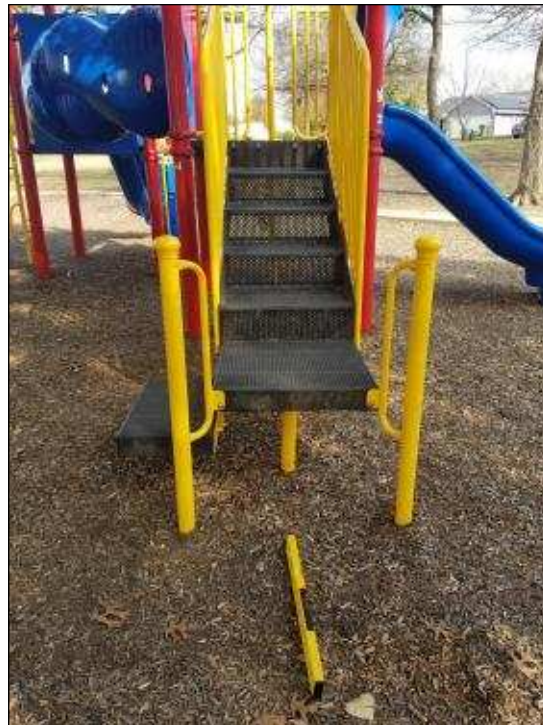
Level 4 (High): Parking and exterior accessible routes (DOJ Level 1) – moderately out of compliance

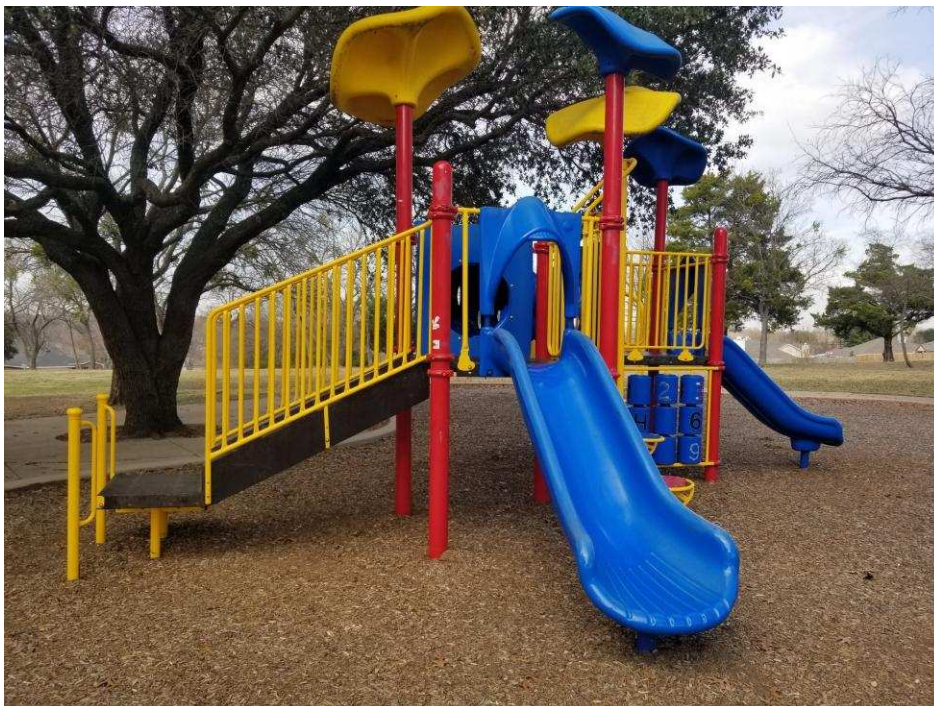
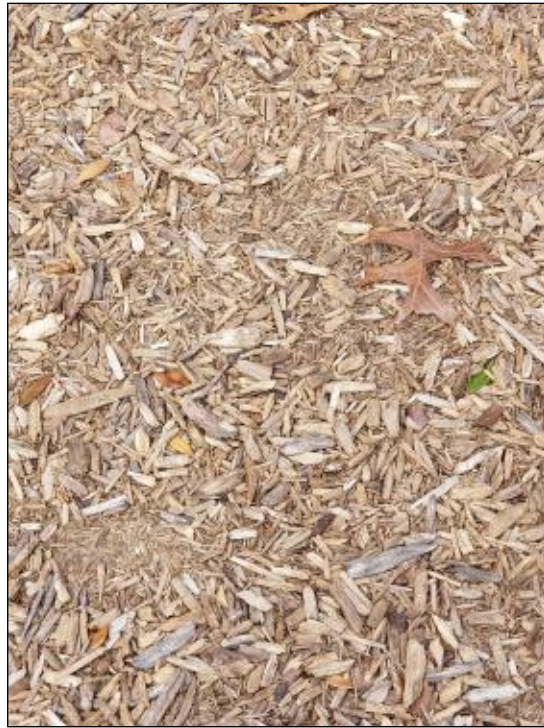
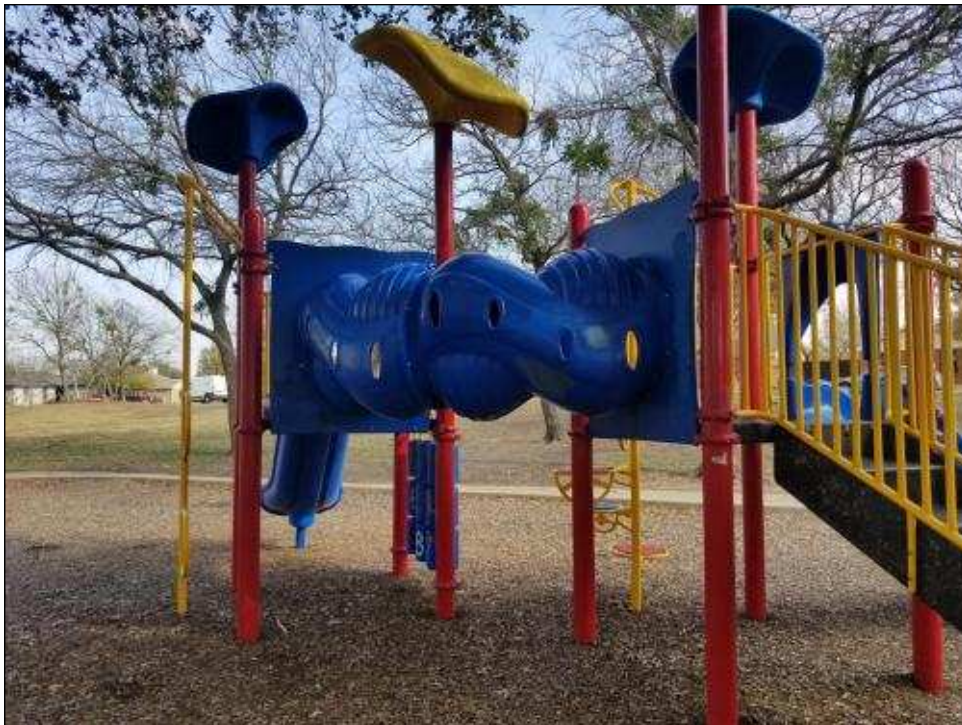
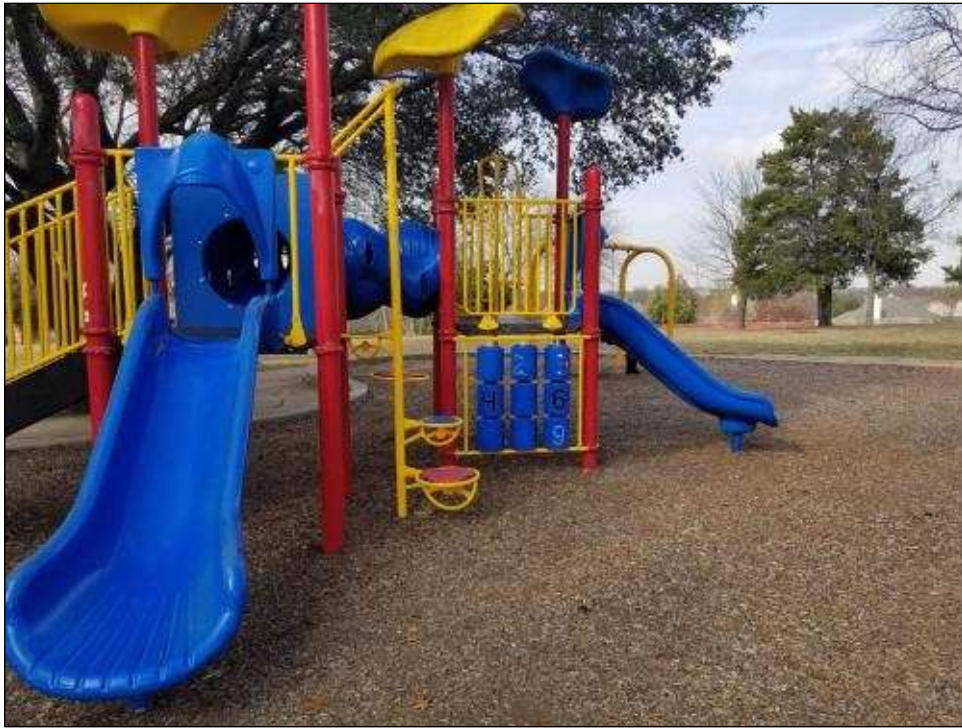
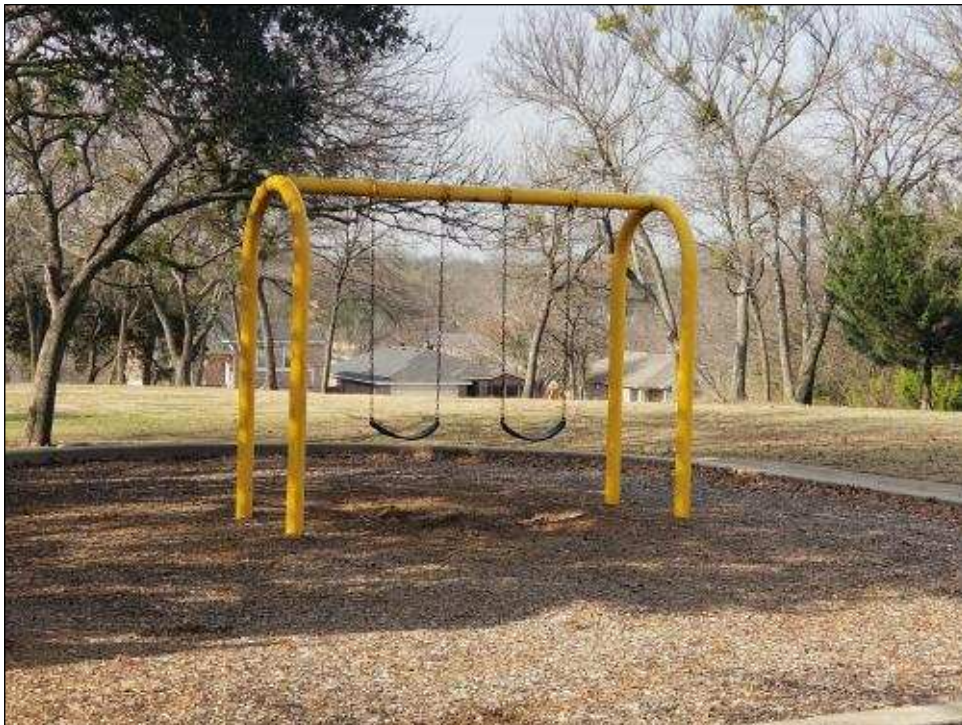
Level 4 (High): Parking and exterior accessible routes (DOJ Level 1) – moderately out of compliance

Maintain records with a certificate from the manufacturer that shows compliance with ASTM 1951 and ASTM 1292, or replace the current mulch with mulch that complies with ASTM 1951 and ASTM F1292.
