Site Accessibility Evaluation

James Park

Accessibility Evaluation

Evaluation Date: 12/16/2021

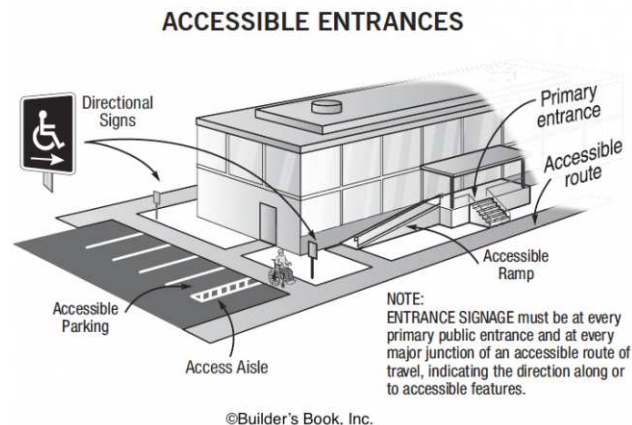
Barrier: 1

There is no accessible route of travel from the public way. At least one accessible route shall be provided within the site from accessible parking spaces and accessible passenger loading zones; public streets and sidewalks; and public transportation stops to the accessible building or facility they serve.

There is no accessible route
of travel from the public way
to the park.

Provide an accessible route of travel from the public way to the park path of travel.

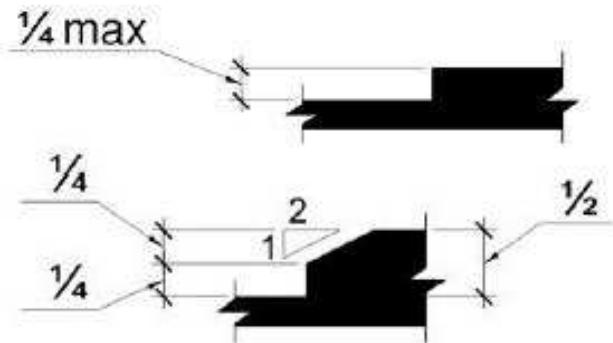
Barrier #2 Additional Barrier Photos

The path of travel contains
abrupt vertical edges
measuring 1 inch.

Modify the path of travel to provide a smooth level surface.

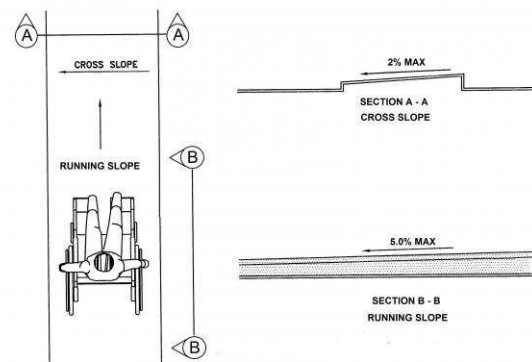
Barrier #3 Additional Barrier Photos

The accessible route of travel contains a cross slope of 2.6 percent.

Modify path of travel to achieve a cross slope that is no greater than 1:48 (2.08 percent).

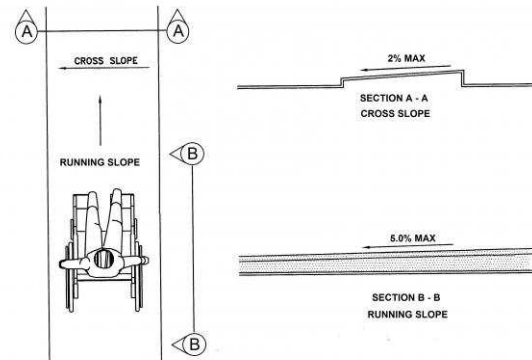
Barrier #4 Additional Barrier Photos

The accessible route of travel contains a cross slope of 4.2 percent.

Modify path of travel to achieve a cross slope that is no greater than 1:48 (2.08 percent).

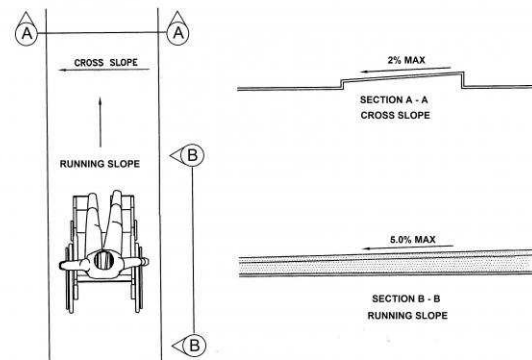
Barrier #5 Additional Barrier Photos

The accessible route of travel contains a cross slope of 6.1 percent and changes in level.

Modify path of travel to achieve a cross slope that is no greater than 1:48 (2.08 percent) and eliminate changes in level.

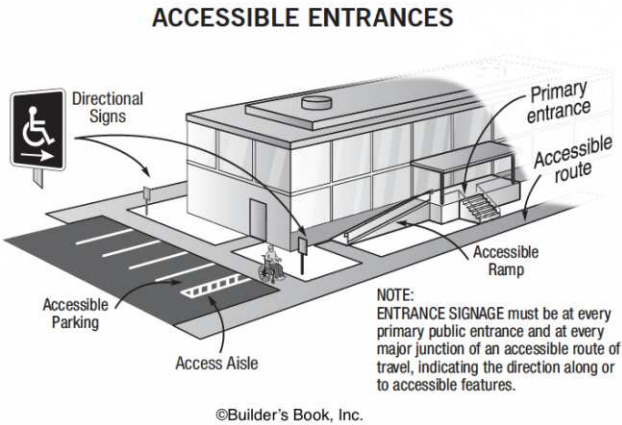
Barrier: 7

There is no accessible route to the trash cans. At least one accessible route shall connect accessible buildings, accessible facilities, accessible elements, and accessible spaces that are on the same site.

Citation:	Current Condition:	Budget Cost:
2010 ADAS Section: 206.2.2	There is no accessible route to the trash cans.	Base Cost: \$1,500.00
1991 ADAAG Section: 4.1.2(1)		Contingency Cost: \$300.00
		Design Cost: \$200.00
		Total Cost: \$2,000.00

Relocate the trash cans closer to the path of travel or provide an accessible route of travel to the trash cans.

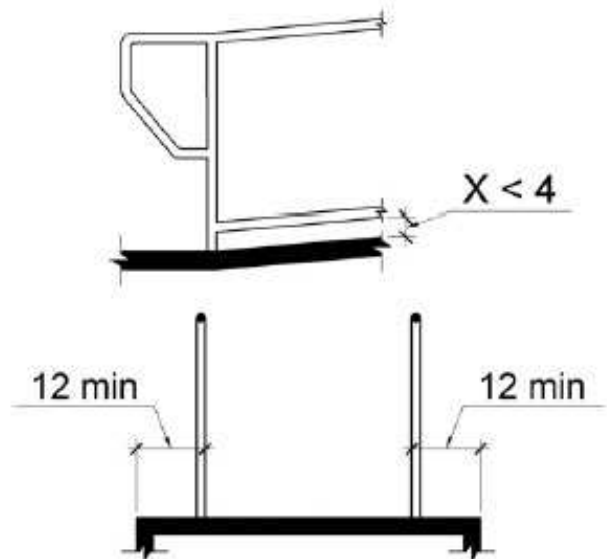
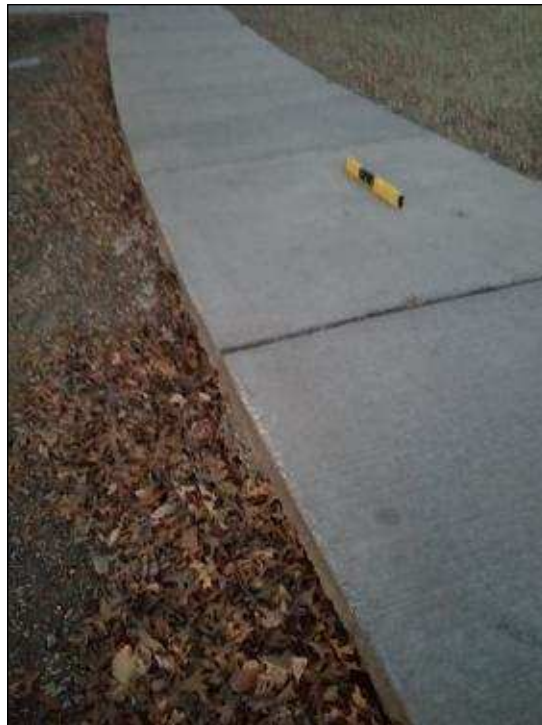
Barrier #8 Additional Barrier Photos

The path of travel has a drop-off greater than 6 inches and edge protection has not been provided.

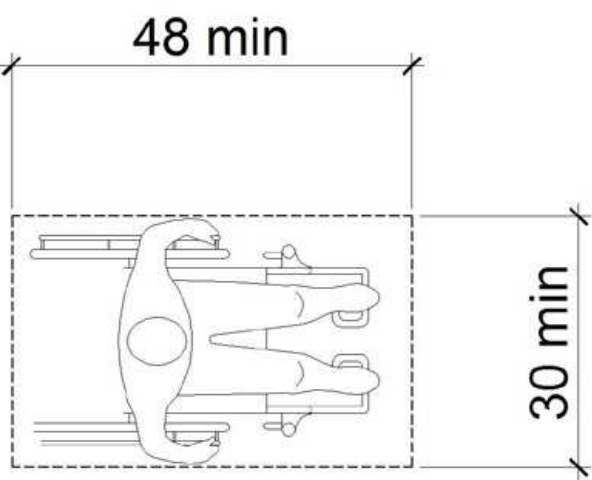
Barrier #17 Additional Barrier Photos

Citation:	Current Condition:	Budget Cost:
2010 ADAS Section: 305.2	The clear floor space required at the trash cans	Base Cost: \$1,500.00
1991 ADAAG Section: 4.2.4.1	contains a 3.2 percent slope.	Contingency Cost: \$300.00
		Design Cost: \$200.00
		Total Cost: \$2,000.00

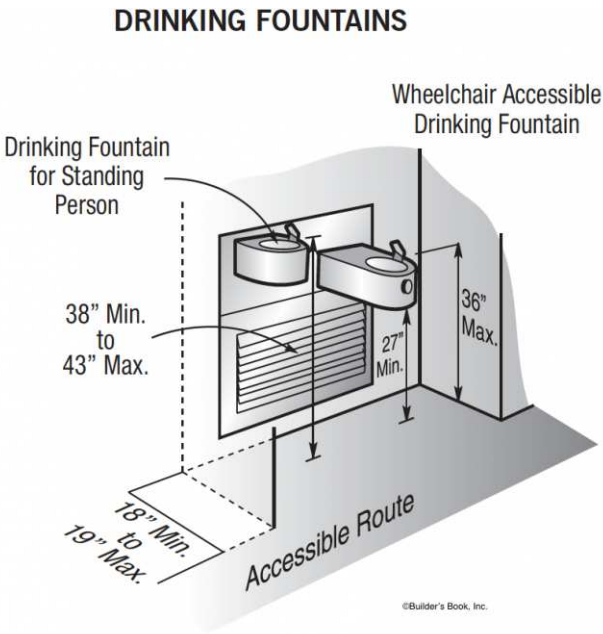
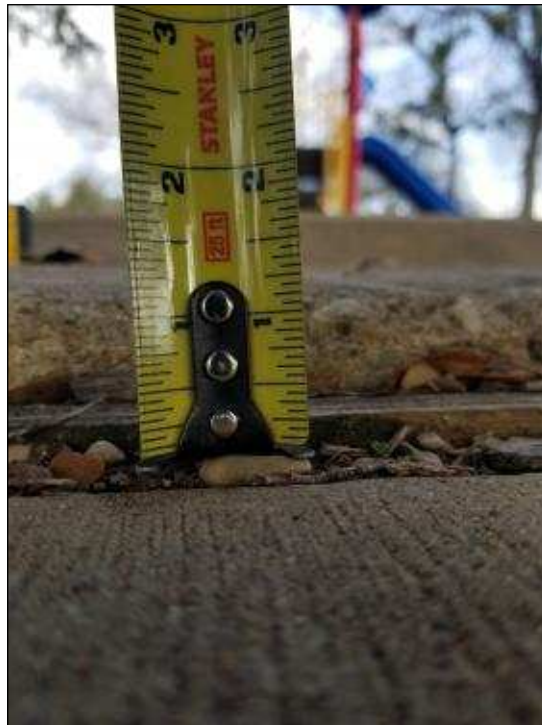
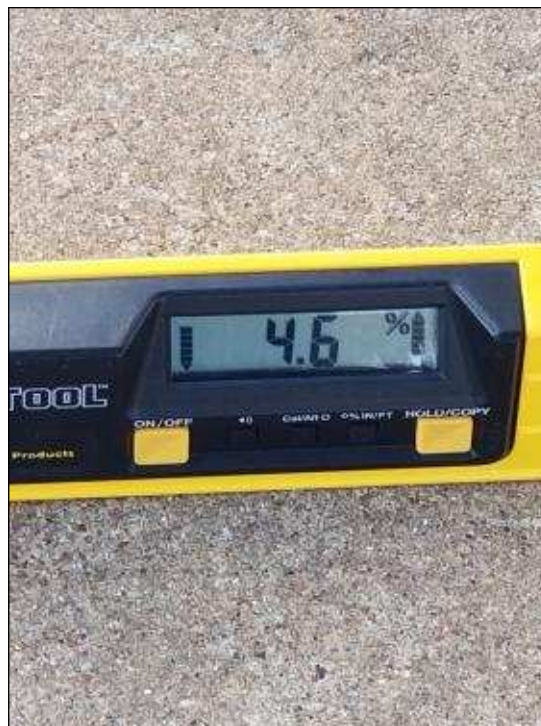
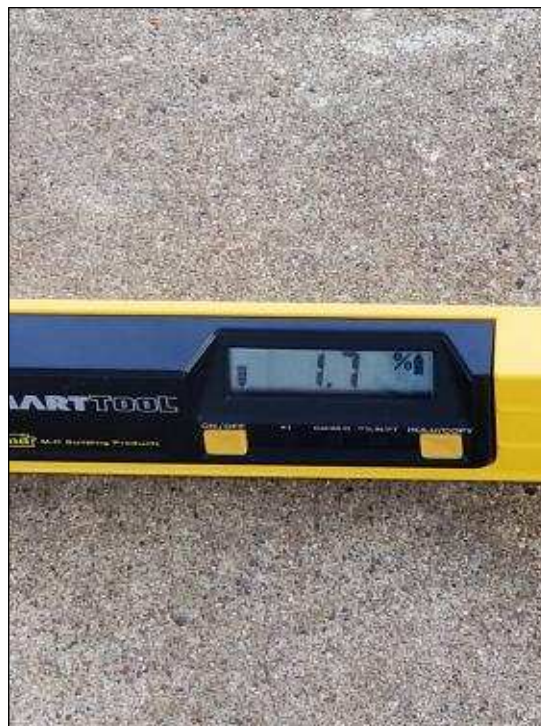
Barrier #22 Additional Barrier Photos

The drinking fountain has multiple violations.
Drinking fountains must be on an accessible route that provides a 30 inch by 48 inch clear floor space centered on the low unit, allowing a forward approach. The spout shall provide a flow of water 4 inches high minimum and shall be located 5 inches maximum from the front of the unit.

Citation:	Current Condition:	Budget Cost:
2010 ADAS Section: 403.5.1, 602.1	The drinking fountain has multiple violations and was not operational at time of evaluation.	Base Cost: \$2,500.00 Contingency Cost: \$500.00 Design Cost: \$400.00 Total Cost: \$3,400.00
1991 ADAAG Section: 4.15.1

Possible Solutions:
Modify the area at the water fountain to provide the required clear floor space with slopes no greater than 2 percent in any direction, and adjust the water flow to provide a minimum of 4 inches.

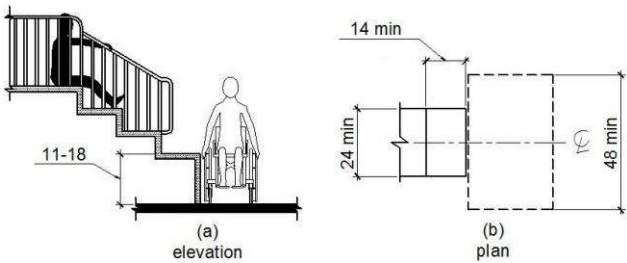
Barrier #25 Additional Barrier Photos

Citation:	Current Condition:	Budget Cost:
2010 ADAS Section: 1008.3.1.1	The transfer platform contains a 2.8 percent slope.	Base Cost: \$1,500.00 Contingency Cost: \$300.00 Design Cost: \$200.00 Total Cost: \$2,000.00

Possible Solutions:
Modify the transfer platform to provide a level surface.
